Thermal images of new Highway Dep building, Jan 16, 2019

External images were taken between 7:15 AM and 7:30 AM before any sunlight was falling on the building (*note: file creation times are 1 hour later due to camera still being set on Daylight Savings time*). Outside temperature was around 15°F, no wind.

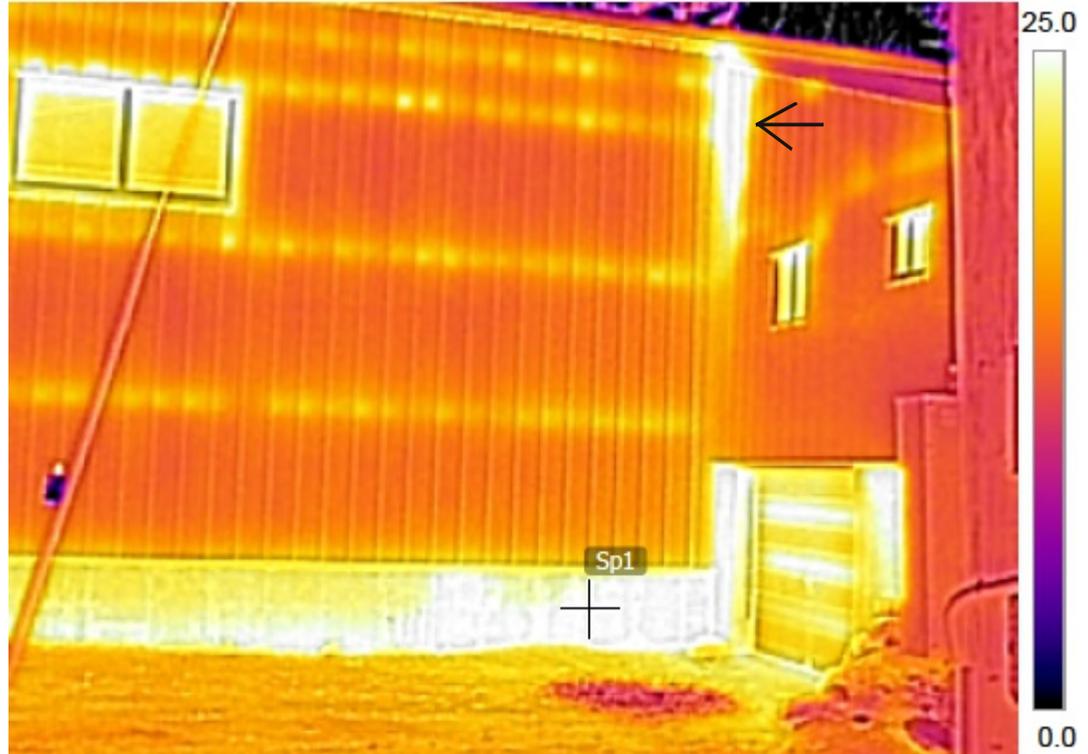
East side showing join with old building.

The rows of yellow dots are caused by the fasteners which secure the sheathing panels through the insulation to the horizontal girts.

Panels are generally around 13°F while the fastener related hot spots range between 20°F at the lower row to 24°F higher up.

Foundation sidewall ranges from 22°F to 26°F. Not unusual as an 8" concrete wall only provides around R-1 of insulation.

Note the high temperature (white) in the upper part of the joint between the new building and the old one. *Temperatures here are as high as 34°F, which suggests poor insulation or failed air sealing.*

- 1) Door at Southern end of East wall does not align properly with its frame - daylight can be seen where the door meets the frame. It may be warped.
- 2a) The joint between the old building and the new one appears to need more insulation or more effective air sealing. This is a problem where the North wall meets the old building and where the old building meets the East wall.

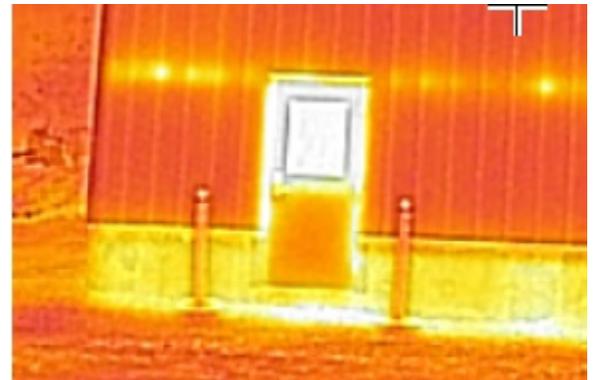
Door on the Southern end of the East wall:

the temperature of the door frame's upper part is around 32°F. Subsequent *inspection from inside showed that the door was not aligning properly in its frame and allows significant air leakage.*

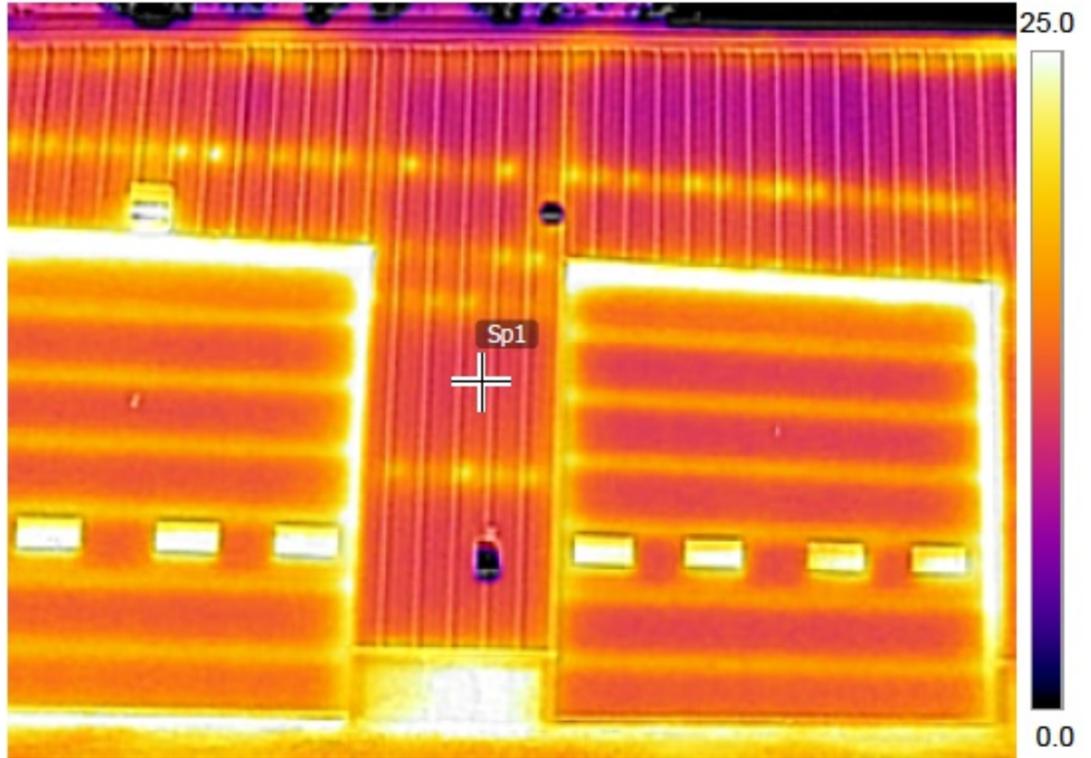
South wall:

Temperatures of door panels between their horizontal hinges is 12°F, similar to the wall panels. The horizontal hinges are around 17°F.

The door frames at the top are around 37°F.

Foundation wall between the two doors is at 26°F.

- 4) The tops of the roll up doors may be leaking warm air, as indicated by the higher external temperatures that were seen.
- 5) The sides of the roll up door frames could use some insulation.

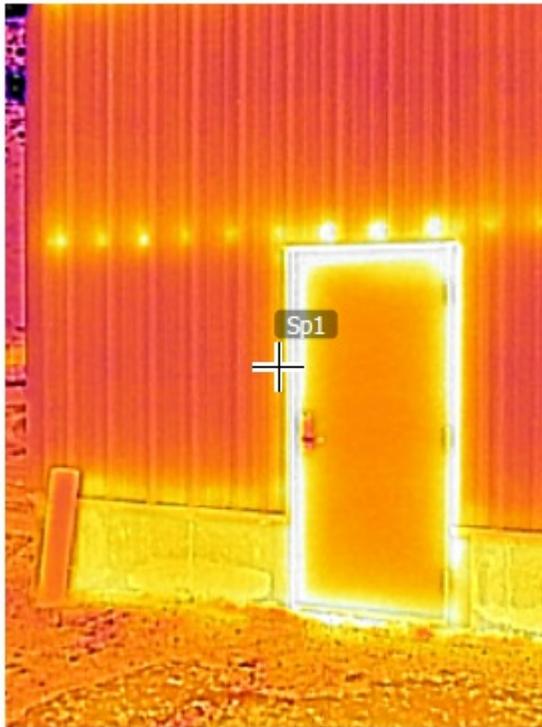
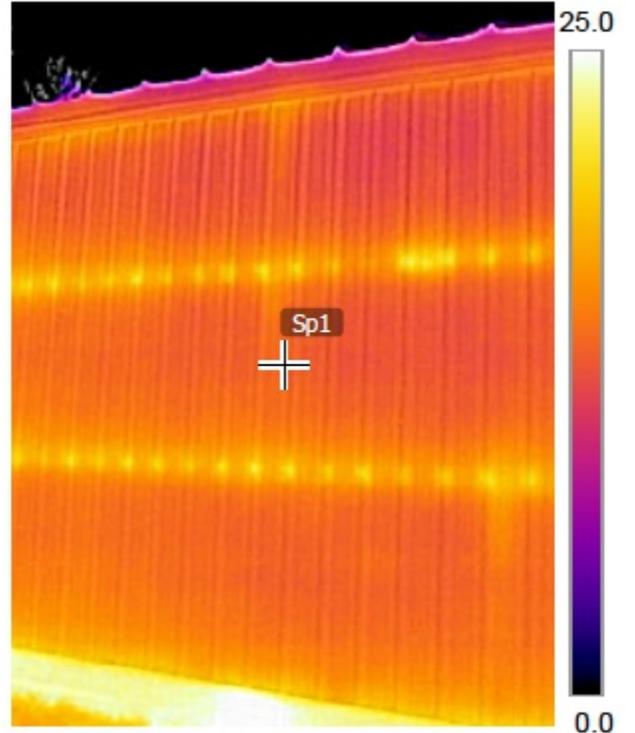
West wall:

Panels at 14°F, fastener hot spots at 24°F

Foundation wall at 20 to 25°F, averaging 22.

Door center 16°F, door frame 32°F, door aligns properly with its frame.

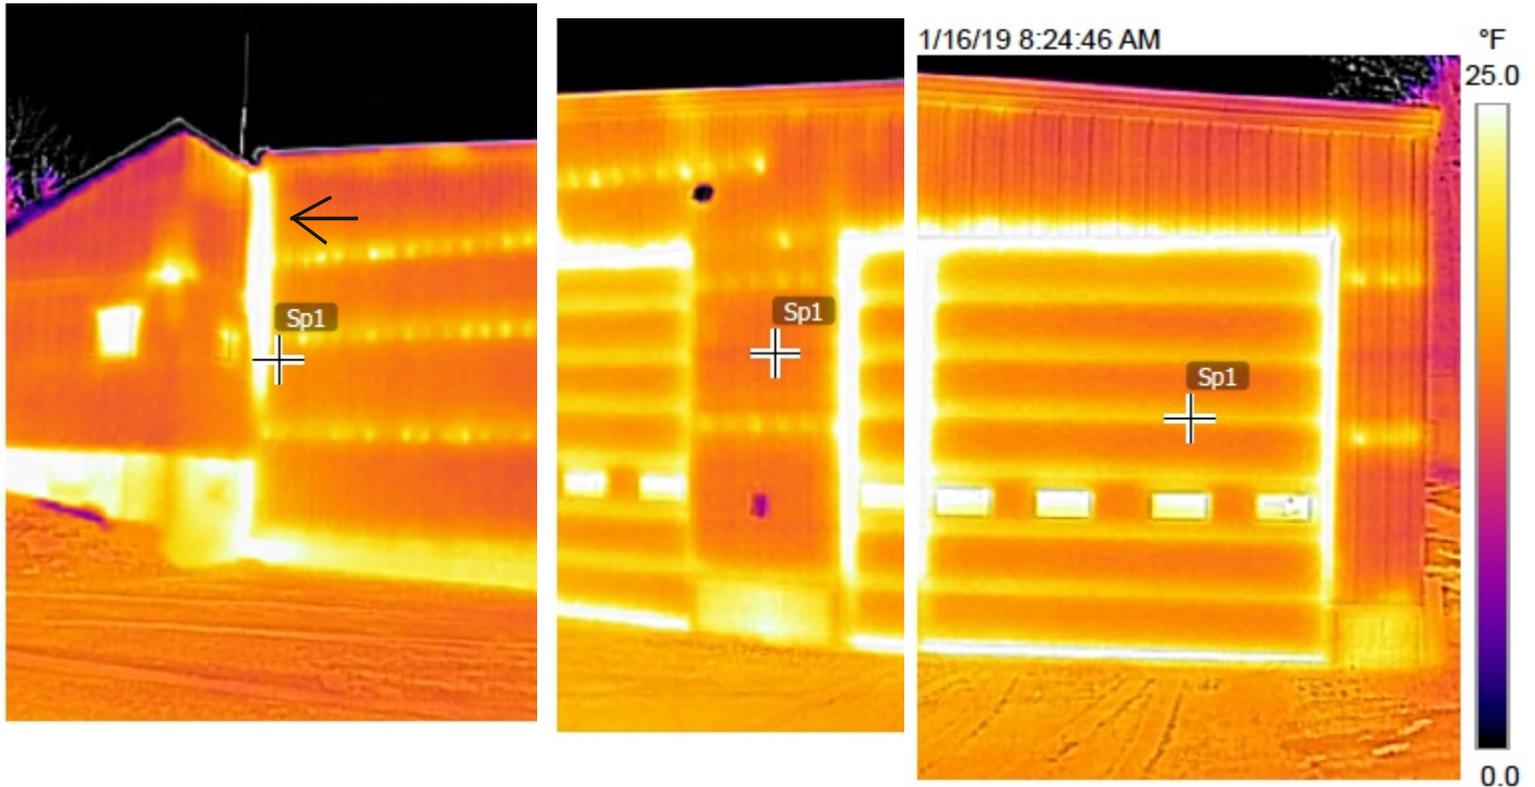
North wall:

Note high temperature area (36°F) where new building joins the old, indicating either insufficient insulation and/or poor air seal. Inspection from inside revealed that cold air was entering in the lower part of the join.

Otherwise little of note - temperatures of wall panels, fastener hotspots, door panel, door hinges and door frames and foundation walls as seen on other walls. (dark spot between doors is my calibration target)

Old building's wall insulation is comparable to new building's. Its foundation wall is at 26°F.

- 2b) There is definite cold air intrusion near the bottom of the seam between the North wall and old building, which may be matched by heated air loss along the upper part of the same seam.

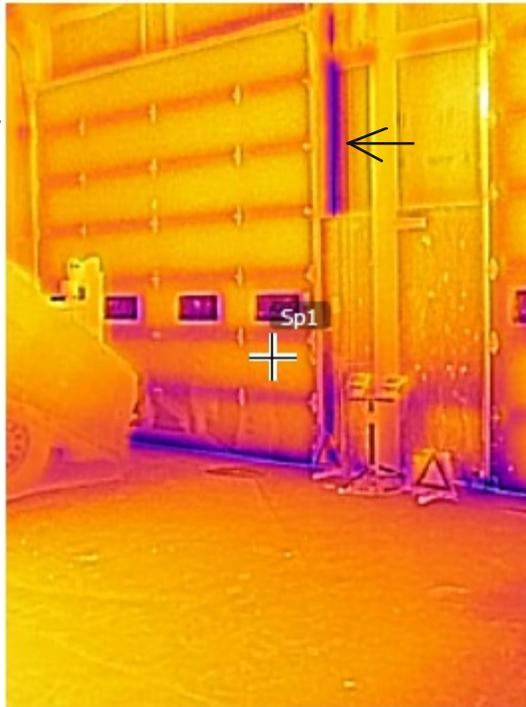
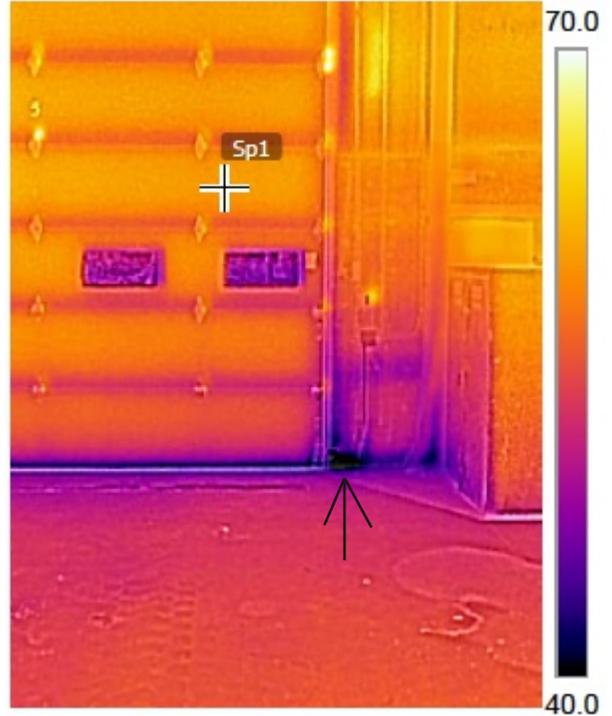
South wall, roll-up doors

Door panels 60°F, door horizontal hinges 56°F, bottom edge 43°F.

Cold spot in right hand image just to the right of the lower right door corner is at 32°F. Suggests poor seal allowing cold air in.

Also note color (dark blue) strip in left hand image along frame. This was seen in all roll up doors.

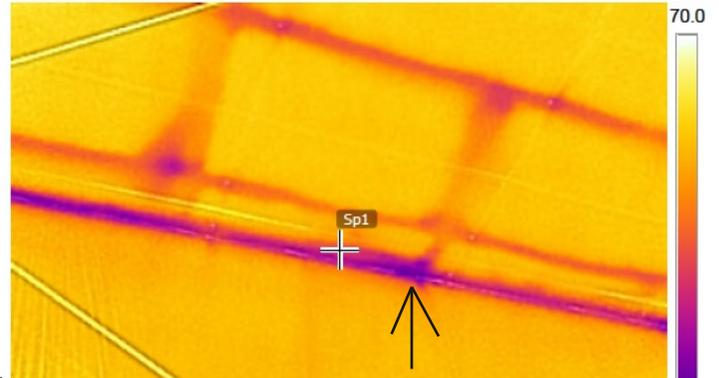
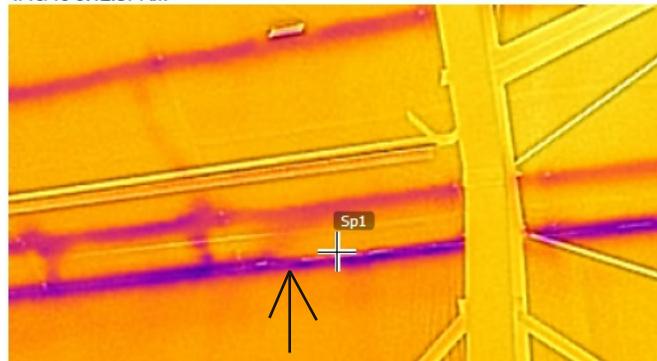
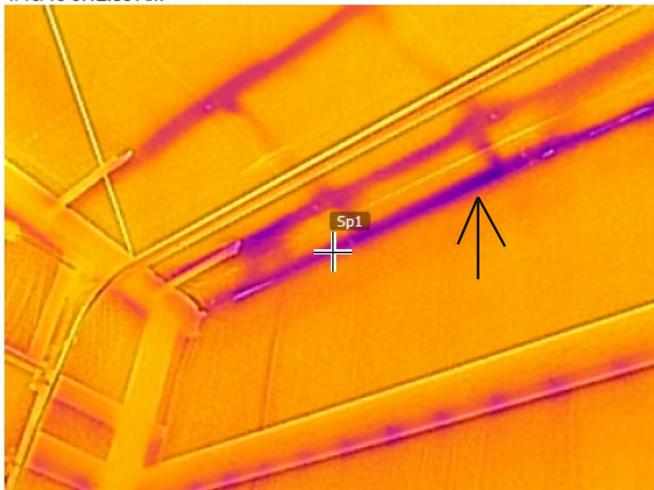
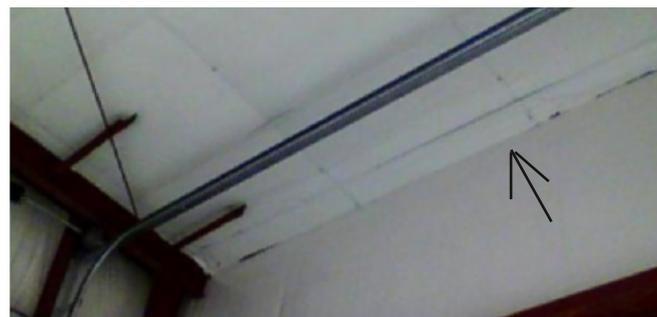
Joint between West wall and roof:

Note cold line (blue) which runs along joint between the West wall and the roof. *Visually it appears that the insulation backings may not have been taped securely and that cold air may be flowing in through the seam.* The same might be true along the East wall but because it is higher the flow there would be of heated air outwards.

- 3) The West wall's seam between the wall insulation and the roof insulation should be checked as it appears there may be cold air leakage all along that seam.
