# Historic Building Assessment

## Mason Hall, Mason, NH

Submitted January 2019 by Weller & Michal Architects Inc.

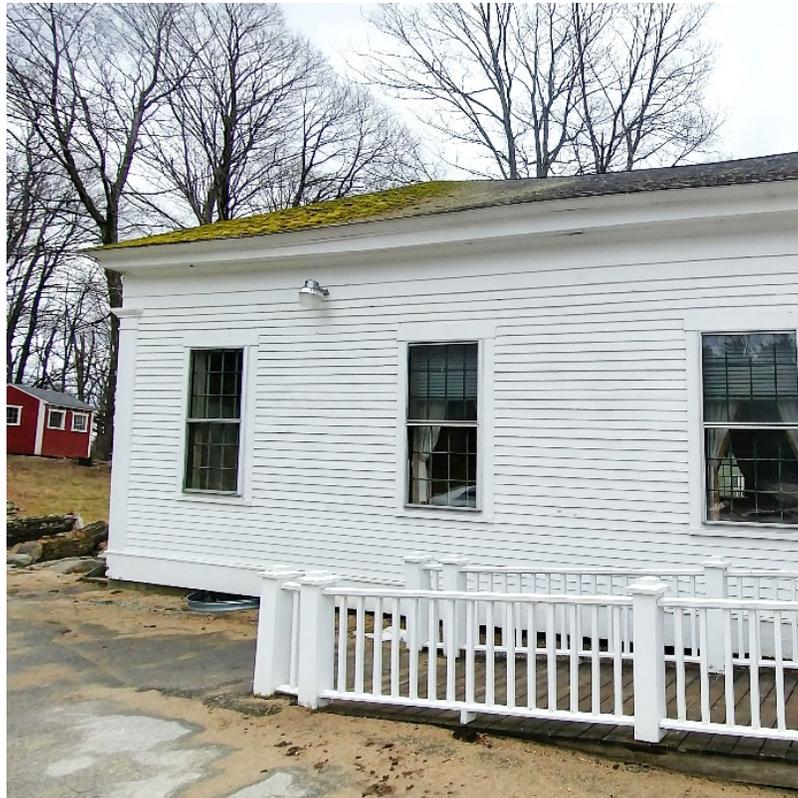
With the exception of the roof, (see Figure 12 - Current Day View looking at north side of roof, below) the building's shell is in reasonably good condition, with relatively minor exterior alterations from the original architecture, notably an accessible entrance ramp located against the north façade and new exterior doors, including a second exit on the south side. Interior historic details remain intact. Gross floor area totals approximately 2,150 square feet on the first floor and 1,150 on a second level.

Figure 12 - Current Day North Side of Roof

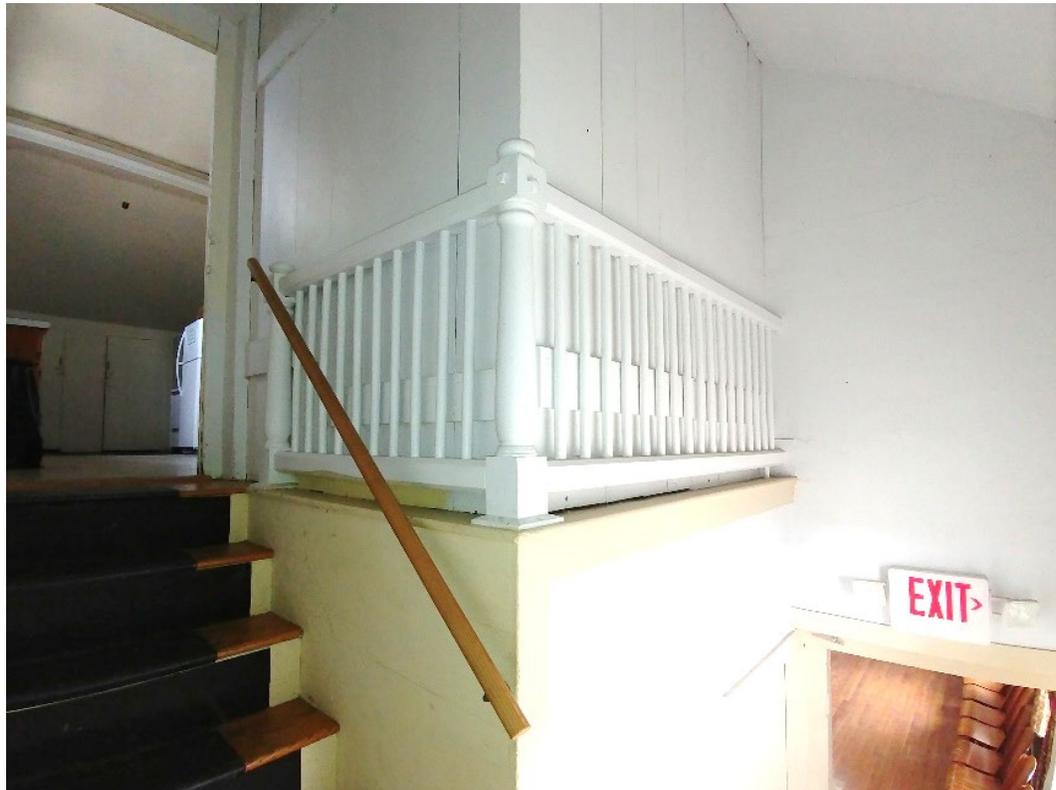
Currently there is no rated separation at the stairwell leading to the second level. An open door frame at the first floor leads to the stair, and a plain board door without true stops partially encloses the upper end of the stair.

Figure 22 – Unenclosed Stair to Kitchen Level

At Mason Hall we can apply the Exception #4 to IEBC 703.2.1, which states:

*4. In Group A occupancies, a minimum 30-minute enclosure shall be provided to protect all vertical openings not exceeding three stories.*

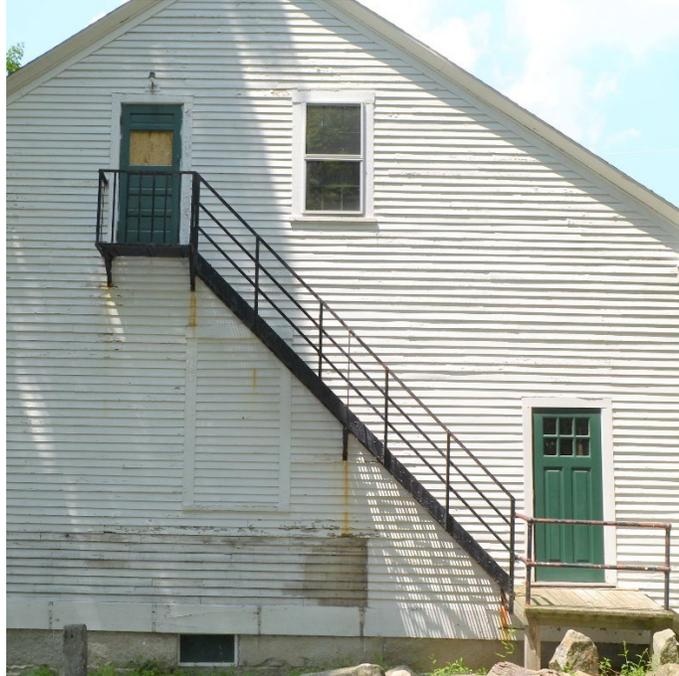
Figure 23 – Window Blocked at Stage below Fire Escape

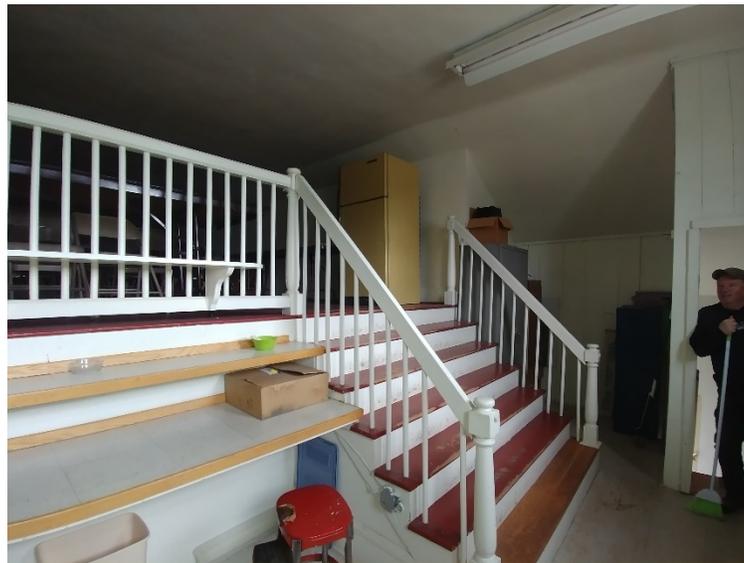
Only the white paint found on stair/mezzanine railings (Figure 25) exceeded the State of New Hampshire and the U.S. Housing and Urban Development (HUD1) guideline for Lead (greater than 0.5 percent [ $> 0.5\%$ ] Lead by dry weight).

Figure 25 – Railings at Upper ‘Kitchen’ to ‘Dining’

Mason Hall will need to be repainted on the exterior by a professional subcontractor using current-day (non-lead) paints. The painting subcontractor must use industry standard practices in preparing the building for repainting, as the existing exterior paint is reasonably assumed to contain lead.

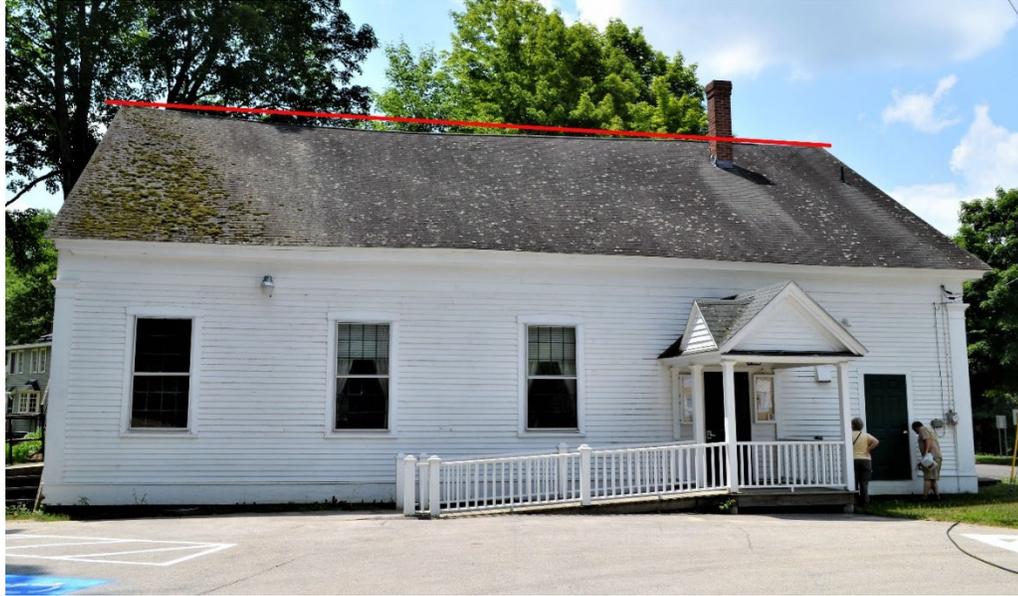
Major structural deficiencies exist in the structure; made evident by the deflection of roof framing, resulting in the spreading eaves and sagging ridge seen in Figure 26 below. The cause of this condition has been traced to the added building loads created by the Grange period (c. 1898) alterations to the original building (see Original Balcony Framing on page 13).

Figure 26 – Sagging Ridge

In our opinion the excessive loading conditions and original truss system failures observed (see Structural Conditions page 21) cannot reasonably be resolved and repaired without eliminating the inserted floor level in the four truss bays over the main hall.

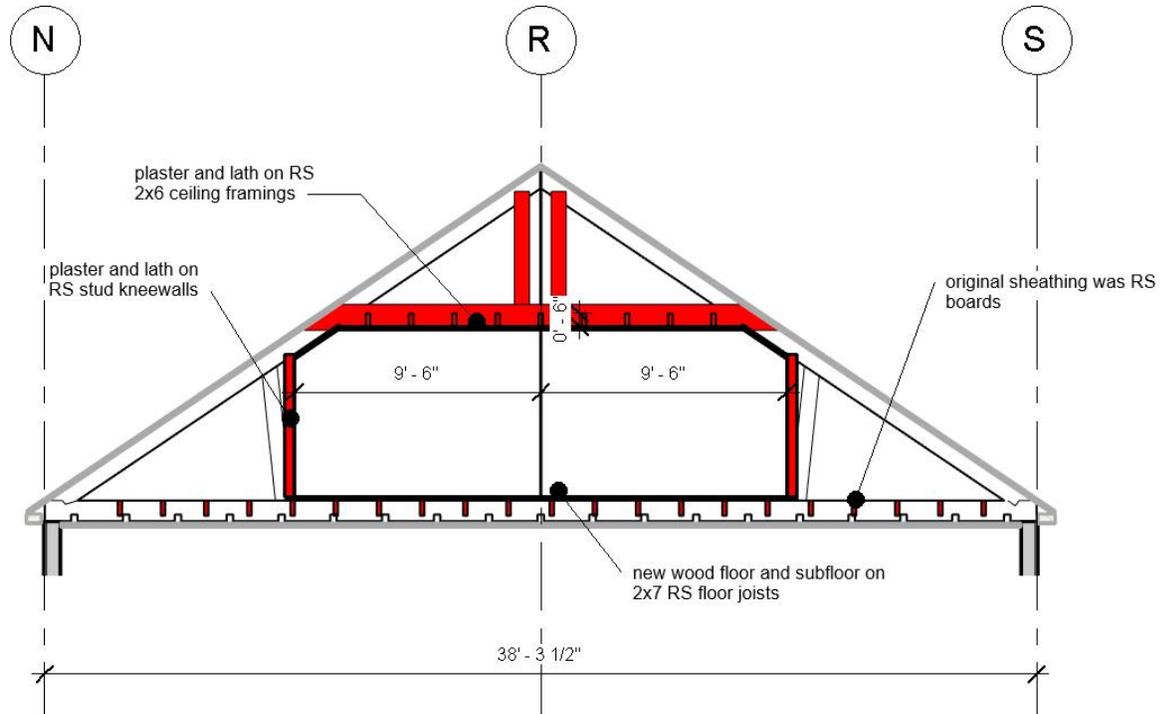
added floor framing	1,200 lbs
plaster and lath ceiling	2,000 lbs
plastered knee walls	1,800 lbs
furniture	1,000 lbs

Figure 29 – 1885 remodeling superimposed on truss diagram

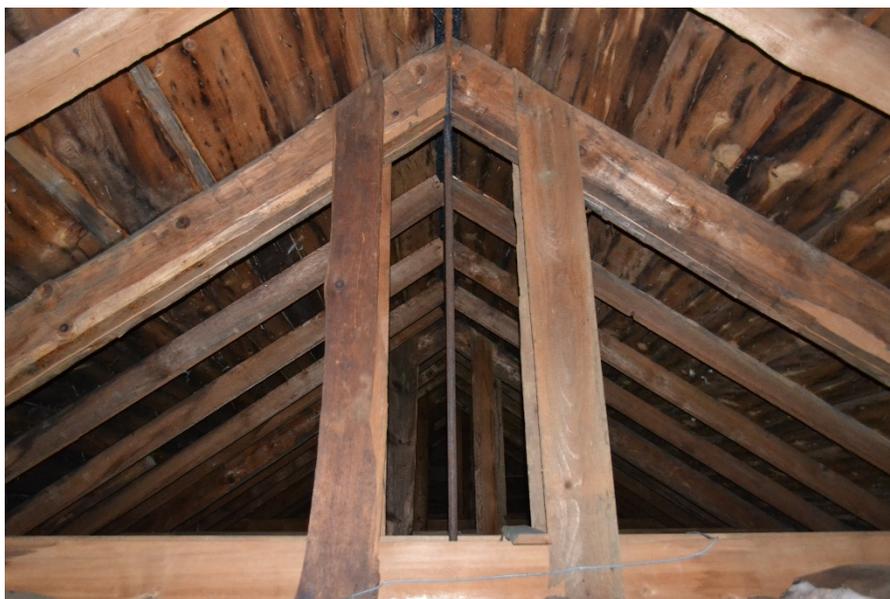
Figure 31 – 1885 Grange truss modifications

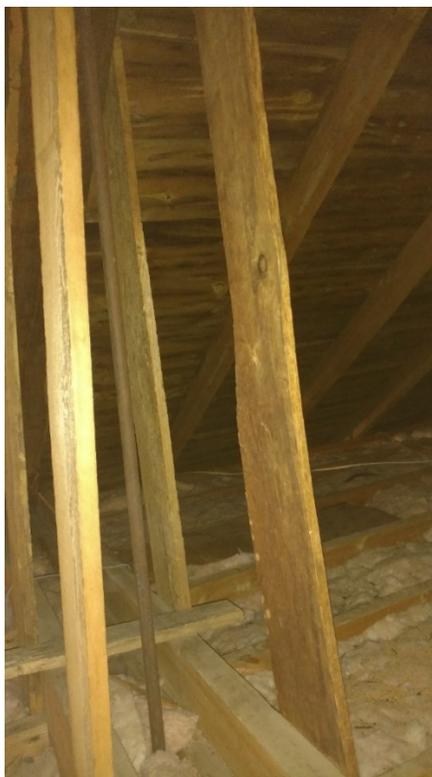
Figure 32 –1885 Grange alterations showing ceiling hung from top chord

This has overloaded the original construction and led to failures at multiple roof trusses. Attempts seem to have been made at different times to reverse or slow the failure by the introduction of secondary elements. These 'repairs' are not structurally informed and have actually contributed to the severe deflection and deformation of the roof line (see Figure 26 and Figure 33).

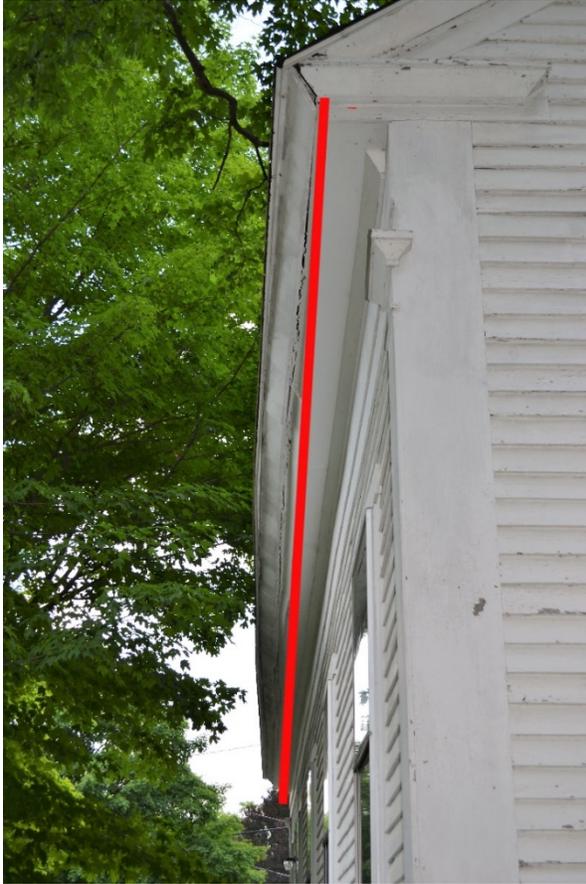
Figure 33 – Distortion at Eaves

Distortion at the eaves and visual evidence in the attic (see Figure 36 and Figure 37) suggests that the failing trusses have not pushed the north and south walls apart. No evidence of significant wall movement from plumb was detected by field measurements. The outward movement of both rafters and upper truss chords has pushed the soffit and roof fascia trim into a bow.

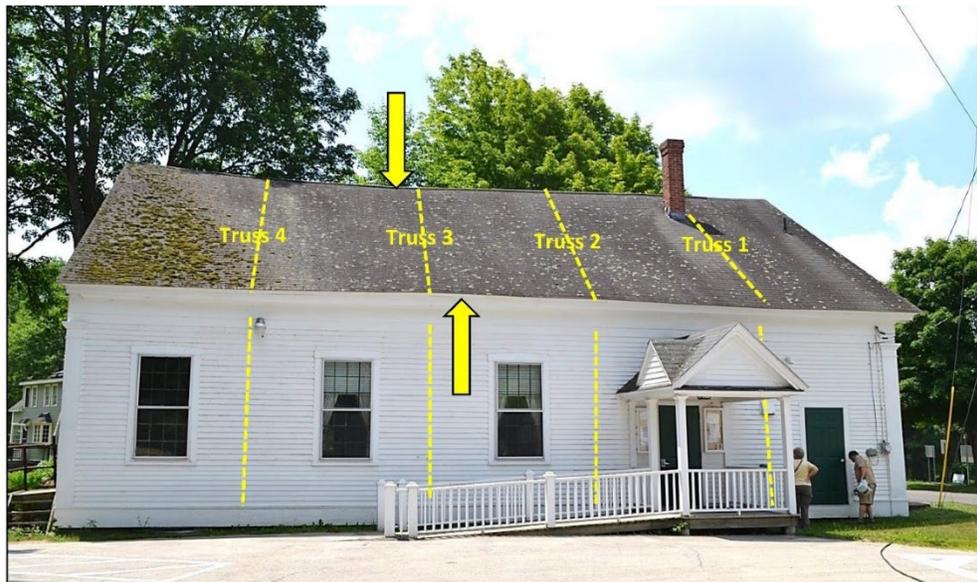
North elevation of Mason Town Hall, showing subsidence of the ridge line and deformation of the eaves (arrows). The yellow dashed lines represent the locations of the principal wall framing bents and of the roof trusses above the bents.

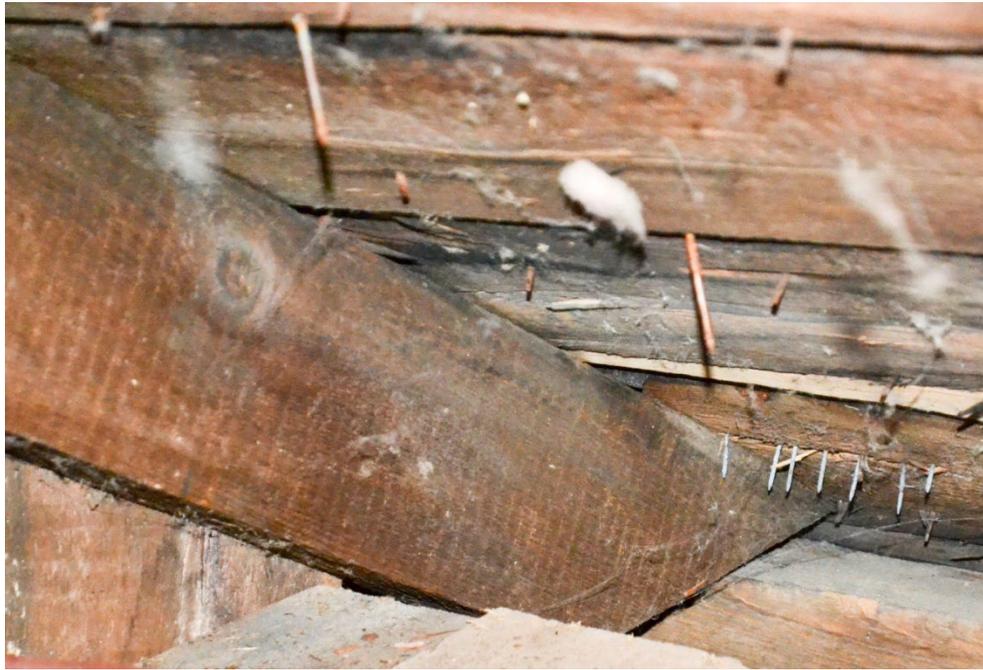
*In summary, the reason for the deflections of the roof is a failure in the joints at the feet of the principal rafters of the building, which are the top chords of a series of kingpost trusses. This failure led to the subsequent outward slippage of the feet of these rafters or upper truss chords. Movement of the upper truss chords (principal rafters) has caused subsidence of the purlins that span the intervals between these principal rafters or chords. Downward movement of the purlins, in turn, caused outward slippage of the feet of common rafters, which have followed the feet of the principal rafters or truss chords in moving outward. The results have been the dropping of the ridge of the roof toward the eastern end of the building and the outward bulging of the eaves cornices of the structure as the rafter feet have spread.*

Figure 36 – Common rafters slipping outward over wall plate

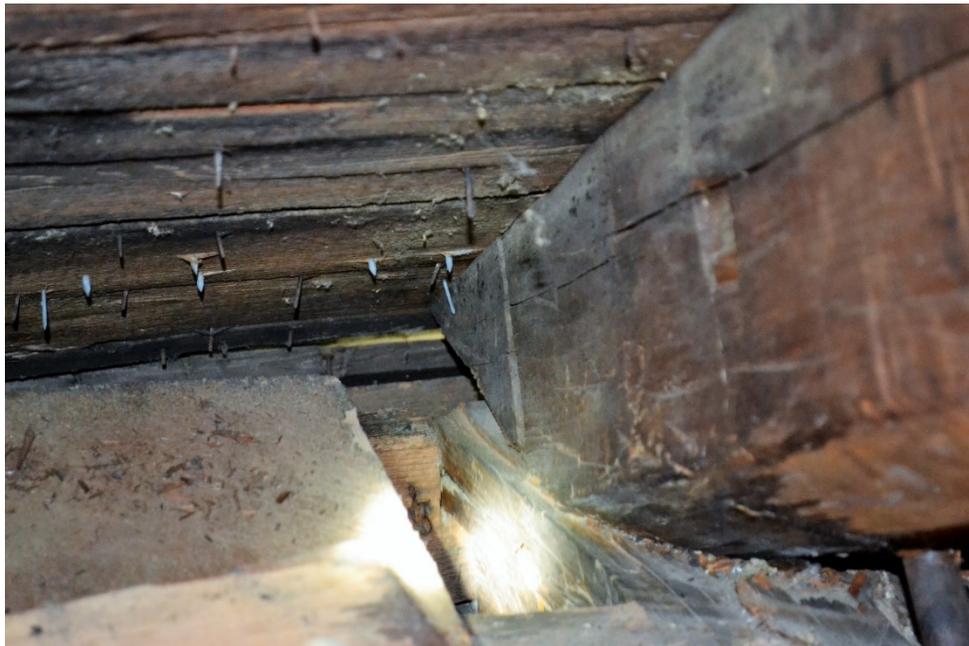
Mr. Garvin is of the opinion that the failure occurred prior to the 1885 Grange modifications and that thru-bolts at the heel of the trusses were attempts to correct and restrain further slippage. Alternatively, the bolts could be original to the 1848 construction of the Howe king-post truss, as are the vertical iron rods which are the principal vertical tension members. Figure 40 – 19<sup>th</sup> century Howe Truss detail showing strut 'heel' mortised into bottom chord and bolted (from Grasmere Grange – Goffstown Town

Figure 37 –Truss upper chord slipping outward over bottom chord

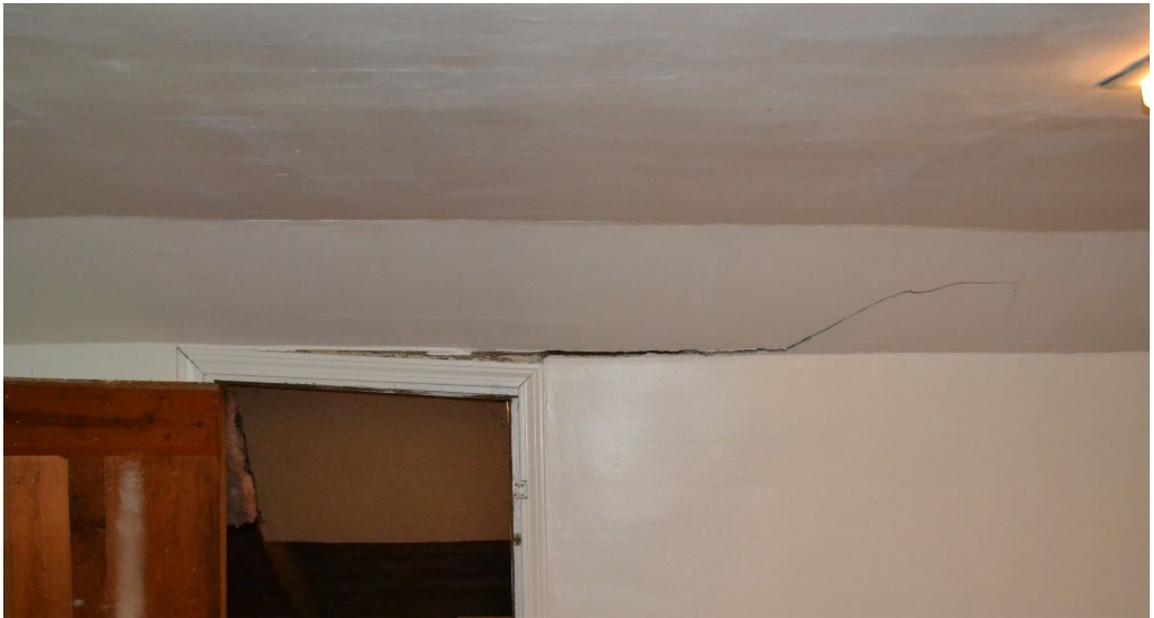
Figure 38 – fractures in plaster knee wall in 1885 dining area

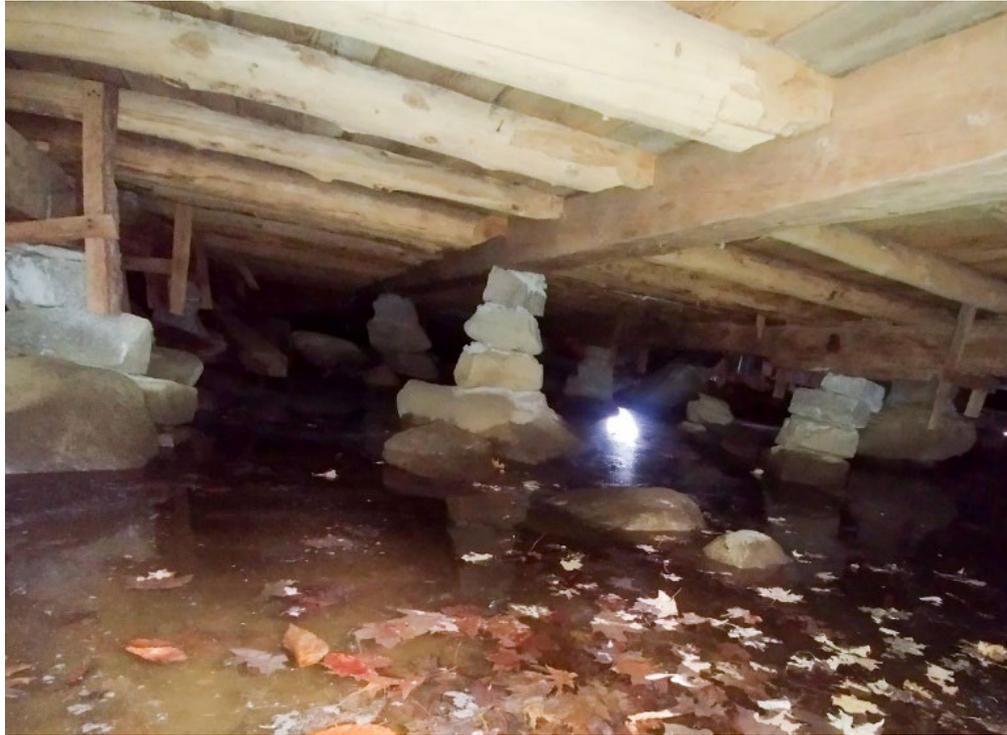
Structural deficiencies at the roof level may have been exacerbated by paving and grading changes in the immediate vicinity of the building, which appear to have directed all water runoff to the crawl space below the building, with no easy outlet. As a result this area is flooded, and allowances should be made to correct problems such as collapsing stone rubble foundation elements and rotting timbers ( see Figure 43 - Flooded Crawl Space).

Figure 42 - Flooded Crawl Space

Poor drainage around the building needs to be addressed. Our recommendation is that the perimeter around the north, east and south sides of existing rubble stone foundation be excavated to allow a French drain system to be installed, to be connected to new storm drainage extended west from the site across and below adjacent roadways, to drain to daylight on the commons. Figure 62 - Site Spot Grades – illustrates how approximately 130 feet of storm drain installed under the street may be possible.

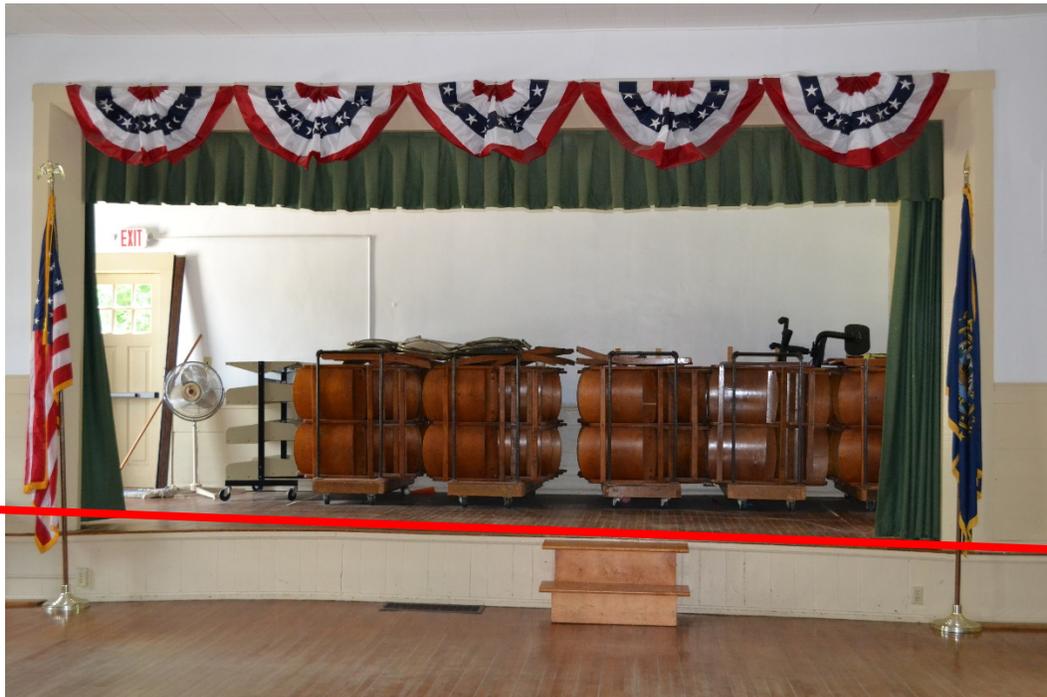
These foundation issues and structural settlement problems can be seen at the main hall level, where the undulating floor structure is prominently seen along the face of the platform stage.

Figure 43 – View of stage with severe drop in floor level to NE corner

Foundation settlement and/or pier collapse in the north-east corner has resulted in a floor level drop of 2 ½ inches over a horizontal span of only 8 feet at the left side of the stage.

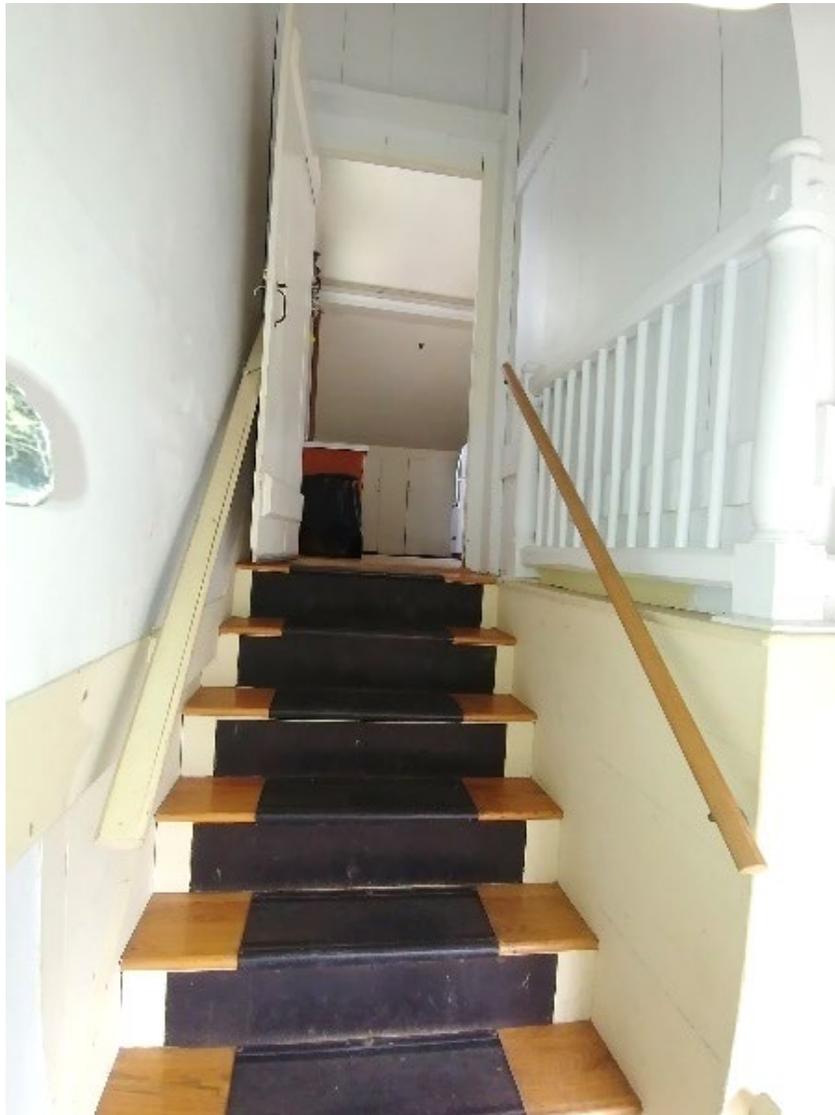
Stairs in historical building seldom meet current life safety standards for public buildings. Mason Hall is no exception. Stair rise and run are almost always steeper than the current code, which limits riser heights to 7 inches and requires a 11-inch tread surface. (With a one-inch nosing, this requires a 7:10 pitch for the staircase.) Furthermore, current standards for handrails (on both sides of the stair, continuous between flights, and 34-36 inches above the tread) are cannot be met by typical historical stair details.

Figure 44 - Steep stair to 'Kitchen' level

Fortunately, "*Existing stairways in an existing structure shall not be required to comply with the requirements of a new stairway as outlined in Section 1009 of the International Building Code where the existing space and construction will not allow a reduction in pitch or slope.*"<sup>11</sup>

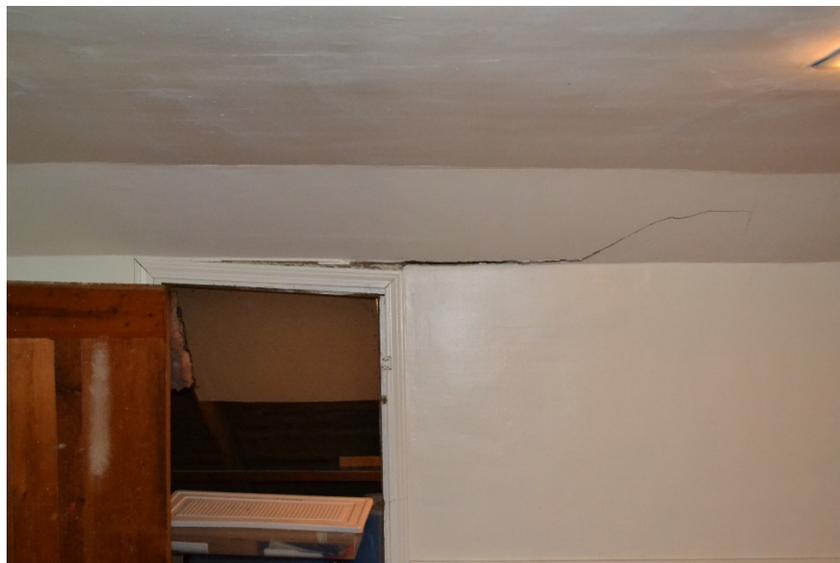
Figure 48 – Dining Hall level lath and plaster partition stress cracking

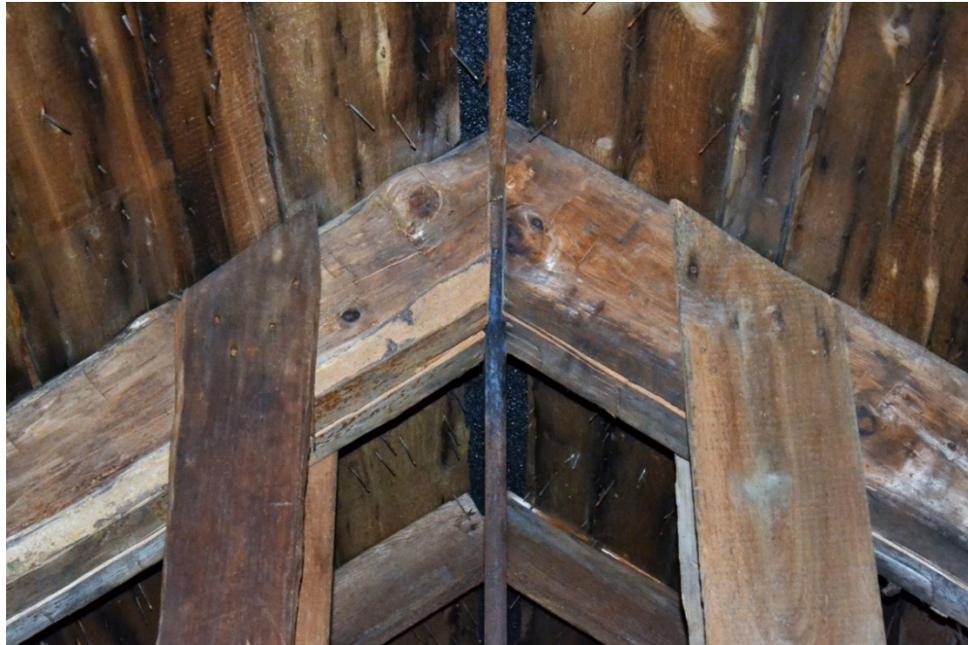
The existing asphalt shingled roof is failing. Heavy moss growth obscures shingles on the northeast side of the roof. Evidence visible in the attic suggests that a contemporary plywood roof sheathing, probably 1/2", has been applied over the original wood sheathing boards. Both the plywood and underlying original sheathing have been distorted by structural movement in the building frame and from the progressive failure of primary roof trusses.

Figure 56 – Roof Sheathing at Truss and Ridgeline

While funds have been appropriated toward roof replacement, significant structural repairs must be made before a new roof is installed.

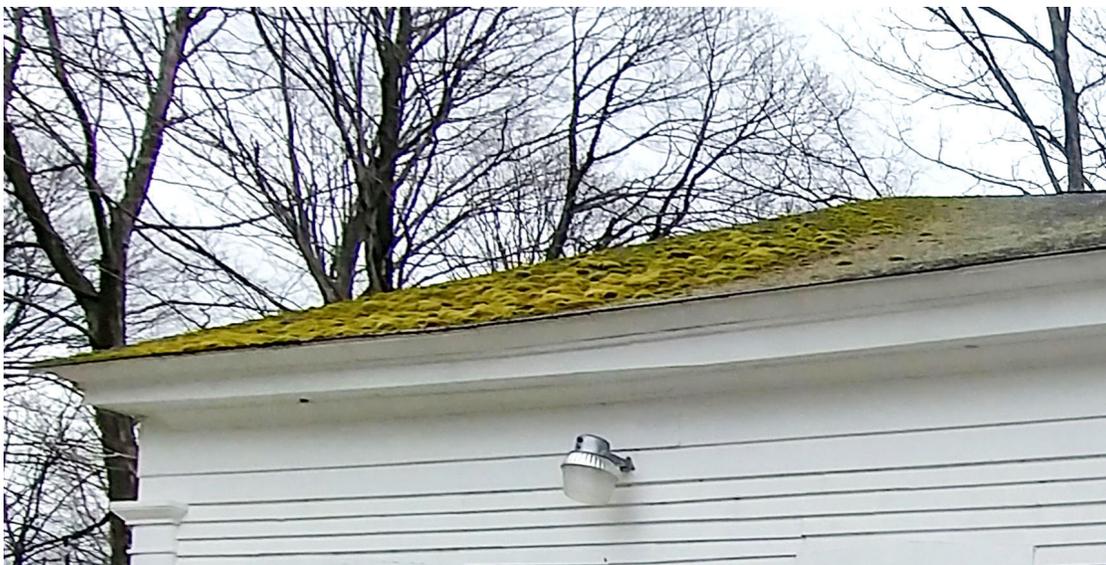
Figure 57 - Moss covered asphalt shingles
