Mason RR Trail Jackson Road Trestle Repair Project, Conservation Commission Final Report

**Mason Railroad Trail, Jackson Road Trestle Repair
 Cross-section, as built June 2013**

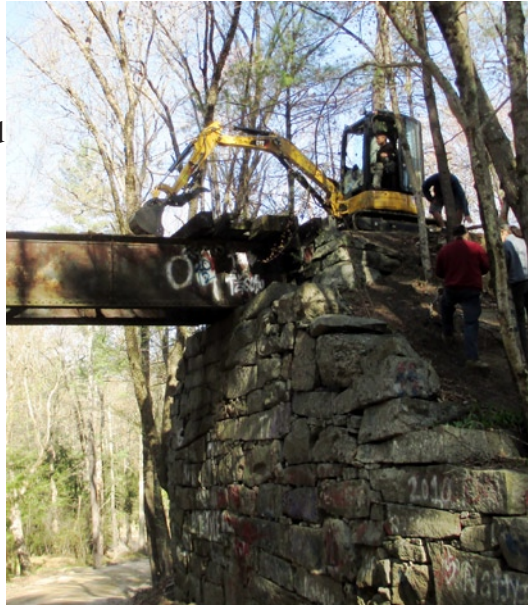
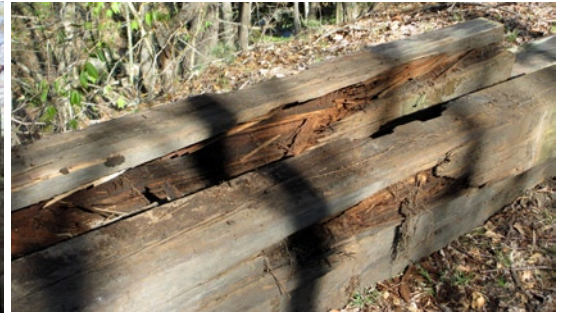
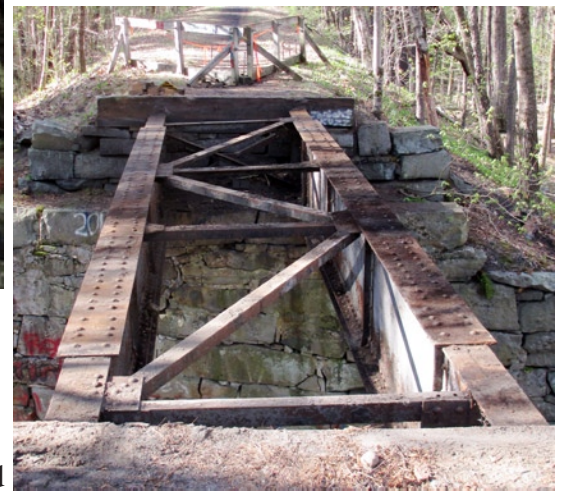
Volunteers from the Wilton Winter Wanderers snowmobile club removed the temporary plywood decking they had installed last year and then, on May 4, brought in an excavator to help remove the ties.

As can be seen in the photograph at the far right, the old ties were long over-due for replacement!

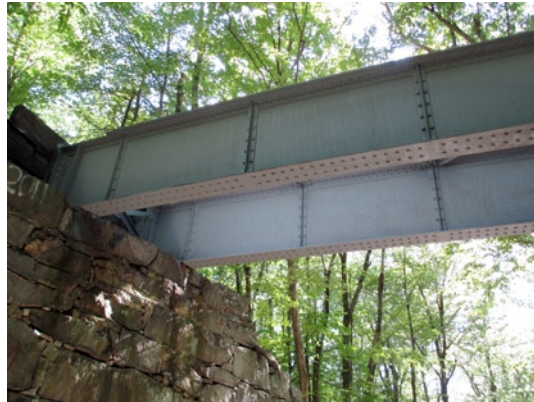
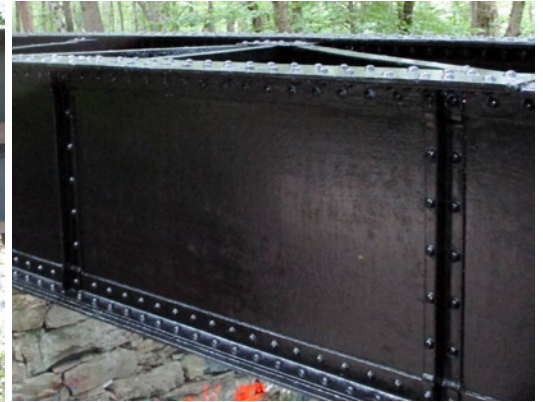
Dan Kuusisto and crew, the painting contractor, finished cleaning and priming the girders by June 5 (first photo at right), but a long siege of wet weather delayed application of the third and final top coat until June 19 (2nd photo).

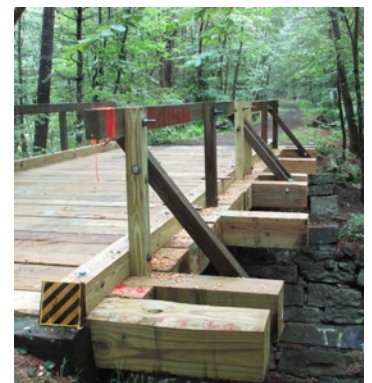
The many rivets used to manufacture the girders in 1850 made their tops uneven, resulting in an uneven footing for the new beams.

Cornerstone Excavation (Eric Anderson and crew) installed pressure-treated 3/4" wood shims between the rows of rivets, as shown at the right. In addition to providing level support these also provide for better drainage and ventilation of the undersides of the new beams as well as protecting the new paint coatings from damage during beam placement. They also spaced the 8" x 10" rough cut pressure treated beams 1/2" apart for further drainage and ventilation - all very important measures for preventing decay for decades.

The majority of beams were 12' long to provide for the 10' wide passageway required by the snowmobile club's grooming equipment plus room for curbing. As shown at the right, a number of 16' long beams were used to provide for diagonal bracing of the guardrails. The 6x6 curbing was attached every 24" to the underlying beam using 18" long 3/4" galvanized bolts. The in-between beams were attached to the curbs using TimberLok fasteners to create a unitary structure.

This deck structure was secured to the girders using fabricated galvanized clamps as shown at the right. Eight such clamps were installed, 4 along the outer edge of each girder, using 9" long 1/2" diameter galvanized lag bolts. These prevent the deck structure from shifting sideways on, or lifting up from, the supporting girders.

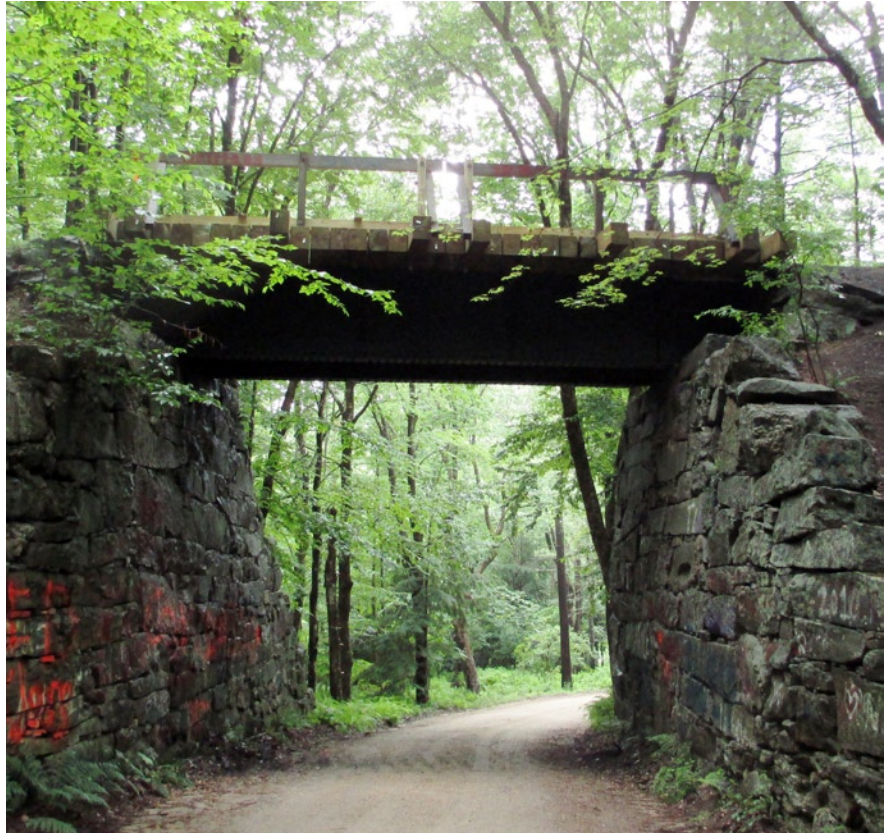
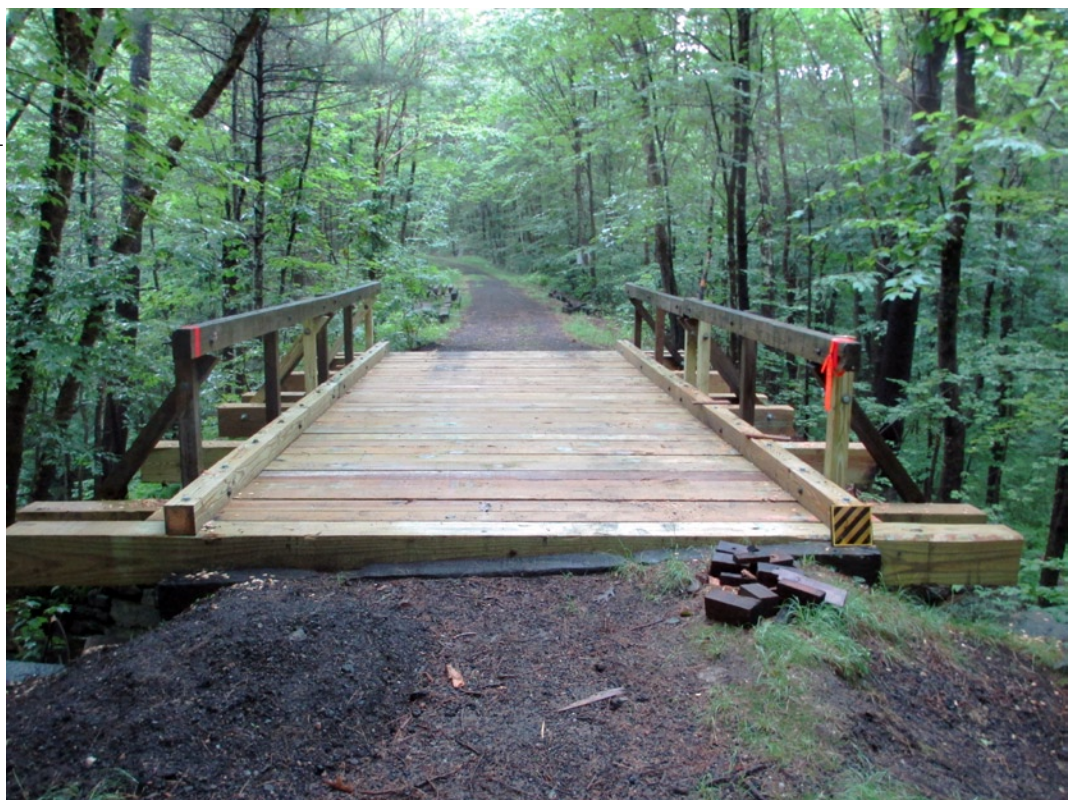
Installation of the deck was finished June 28 and the Mason RR Trail has been re-opened to public use along its entire length.

See photos to right for the appearance of the restored trestle as seen from the East and from the North...
