# Historic Building Assessment

## Mason Hall, Mason, NH

Submitted January 2019 by Weller & Michal Architects Inc.

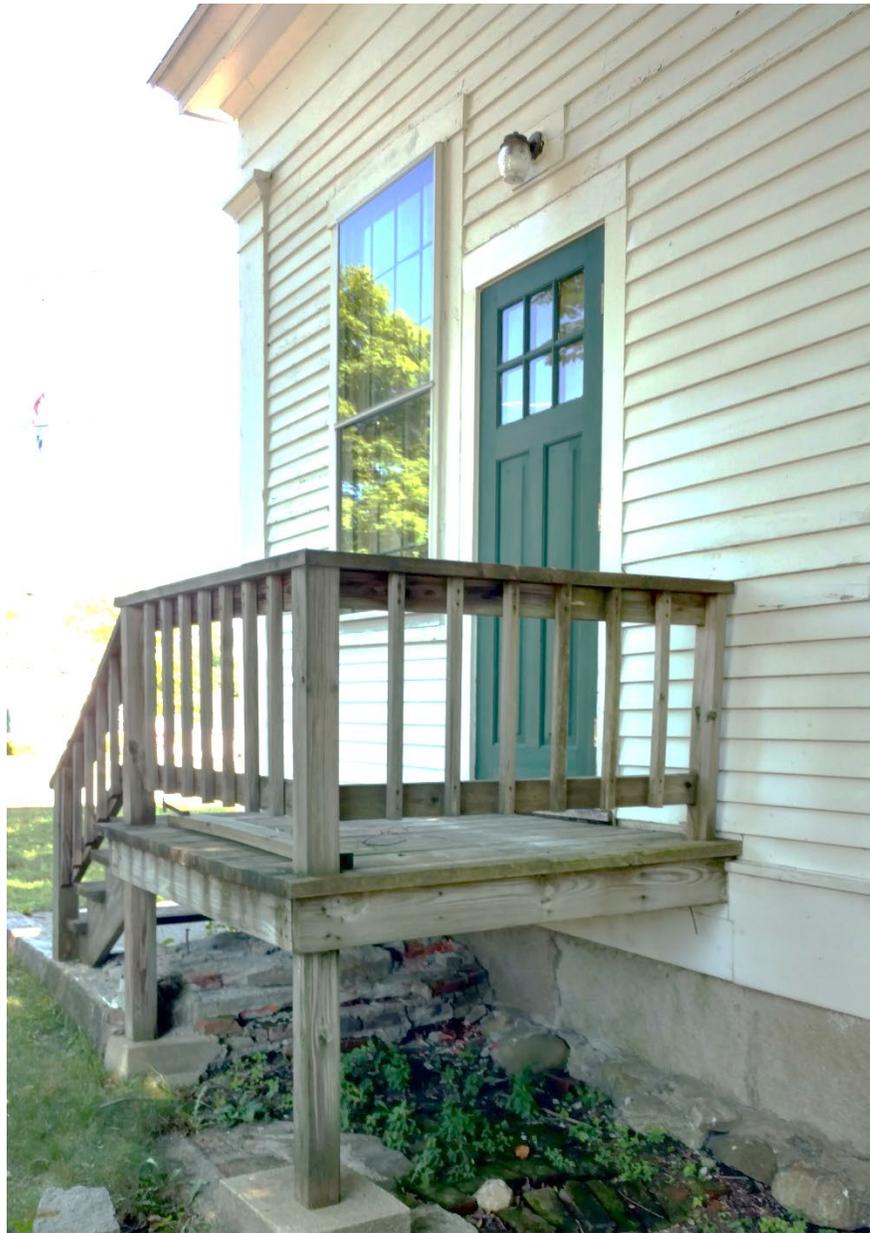
Figure 15 – View of Secondary Exit

The rear elevation is architecturally simpler than the other elevation. The gable end, without wide rake boards or a continuous return, contains one window and a doorway/fire escape in the other original window's location. Only one window remains of the three original window locations on the first floor. Casings from a central window remain and reveals where the original interior selectmen's platform was located. The northeast window was removed and infilled for an exit door located at the stage level, perhaps in the mid-1900s. Clapboard discoloration below the window sills reveal where a ladder storage shed was recently removed.

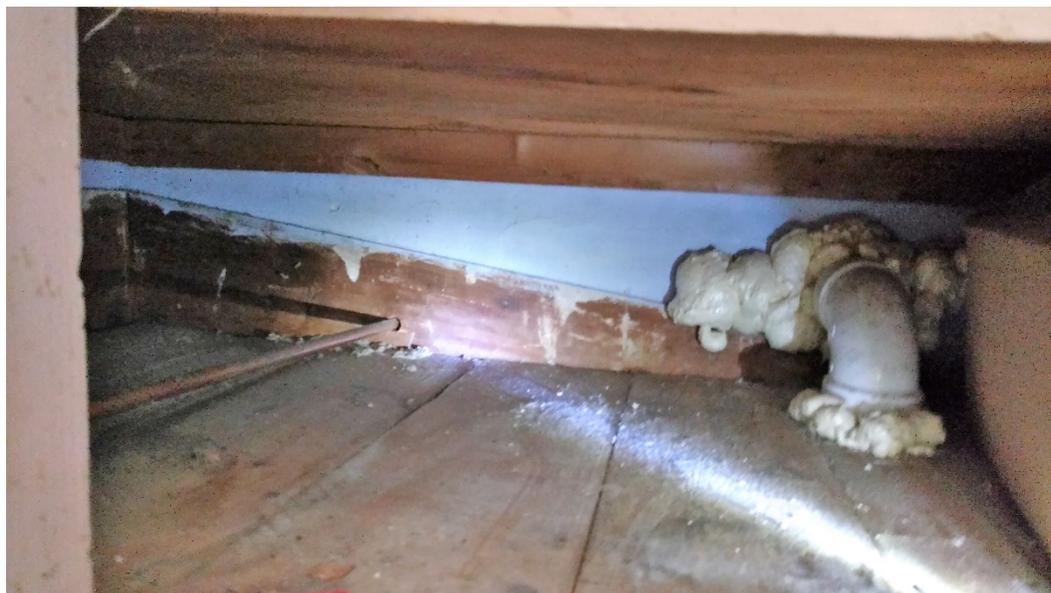
The balcony no longer exists, having been built over as part of the Grange remodeling. Evidence of framing of the original balcony is seen above the ceiling of the first-floor mechanical room, as residual inclined wood base on plaster at the back of a closet in the Grange kitchen (see Figure 18), and by the sloped ceiling planes noted in first floor front entry hall and adjacent 'office'.

Figure 18 – Original sloped balcony baseboard visible at Grange kitchen level

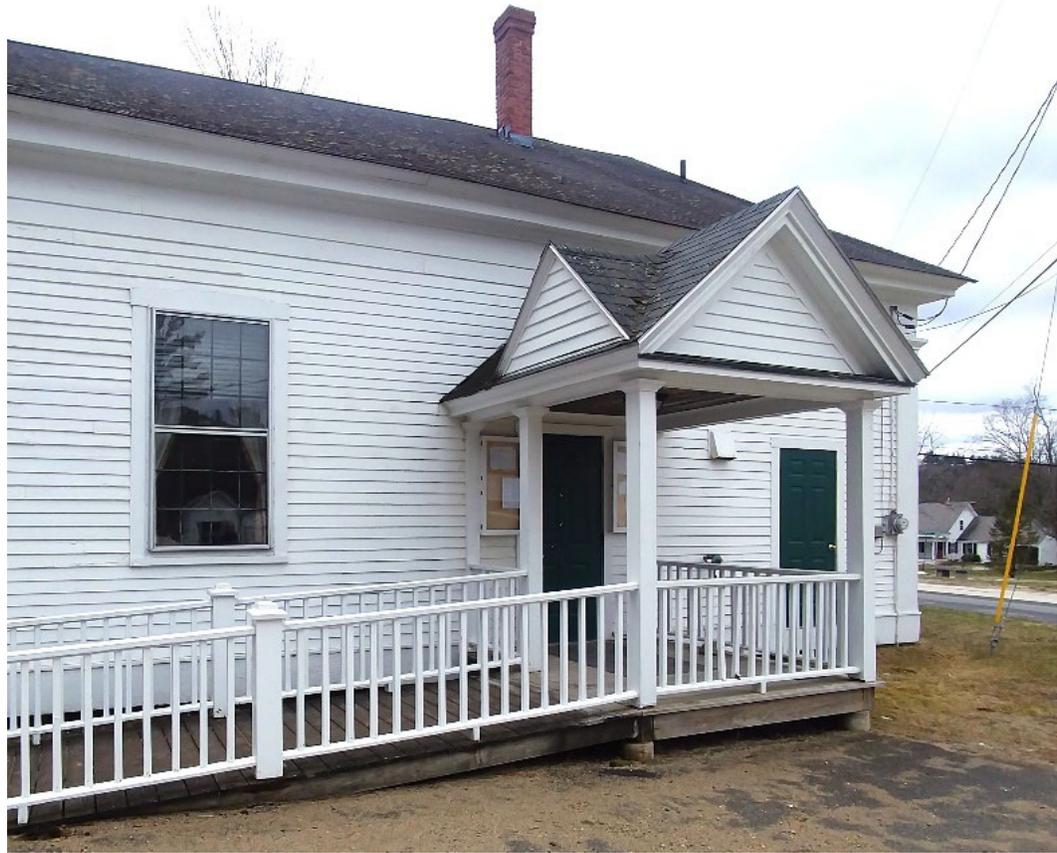
Alterations have already been made to the building which address barrier free access issues and improve accessibility for continued public use as an assembly occupancy. These alterations involved creating a new north side entrance to the main hall with an exterior door replacing an original window, and the construction of a wooden ramp intended to comply with ADA regulations for wheelchair access.

Figure 24 - ADA Compliant Ramp at NW Corner

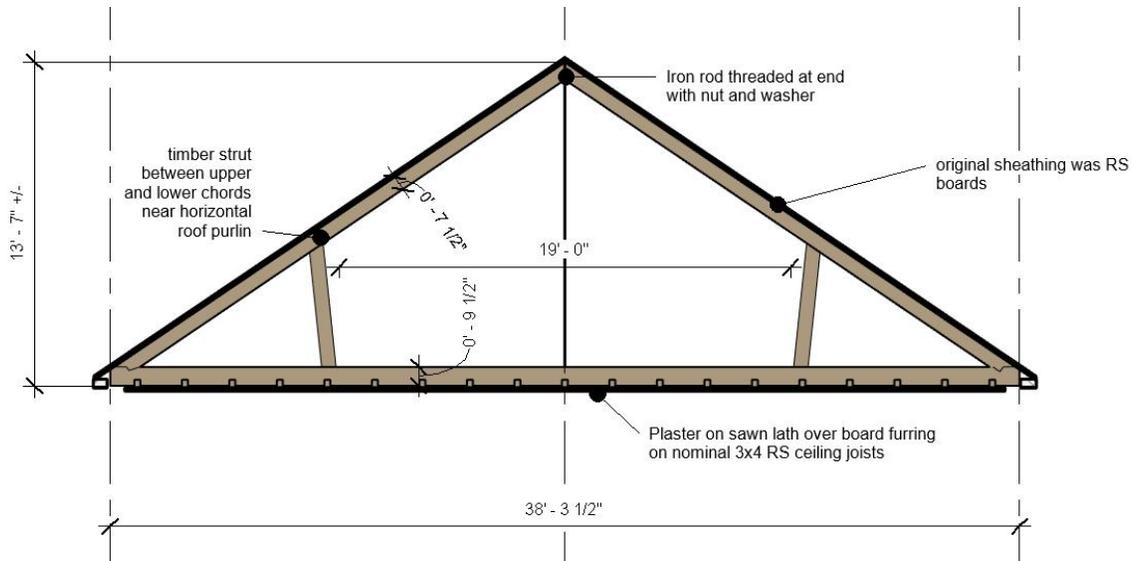
Figure 28 – Original 1848 truss diagram

The original 1848 configuration of rafters, ceiling framing and trusses is illustrated in Figure 28 – Original 1848 truss diagram. Each truss supported at least 430 square feet of structure. The sloped upper truss chord (a nominal 8x8 member) is placed into compression by the truss action, and in bending from the transferred purlin roof loads. The lower chord (nominally 8x10) is placed into tension

by the primary truss geometry and is secondarily placed in bending by the applied gravity (dead) load of the original plaster ceiling and by purlin loads transferred through two struts. A vertical 1-inch diameter iron rod acts in tension at the center of the truss, and the thrust action of the top chords at the left and right ends of the truss is resisted by shearing actions against a thru-bolt of steel and most likely a tenon wood joint between upper and lower timber chord.

The original truss withstood three primary loads – the seasonally applied load of snow, the constant ‘dead’ load of the truss, rafters, roof sheathing and most likely slate roofing, and finally the constant ‘dead’ load of a ceiling supported by the bottom truss chord – consisting of ceiling joists (nominal 3x4) carrying a strapped lath and plaster ceiling above the original main floor, at nearly 13 feet above finished floor.

Without any snow loads, the axial thrust of the top chord against the end bearing panel point would be around 8,300 pounds. The horizontal component parallel to the wood grain of the bottom chord to be restrained by bolts and tenons (in the original) would be around 6,900 pounds – increasing to 20,700 pounds under snow load conditions.

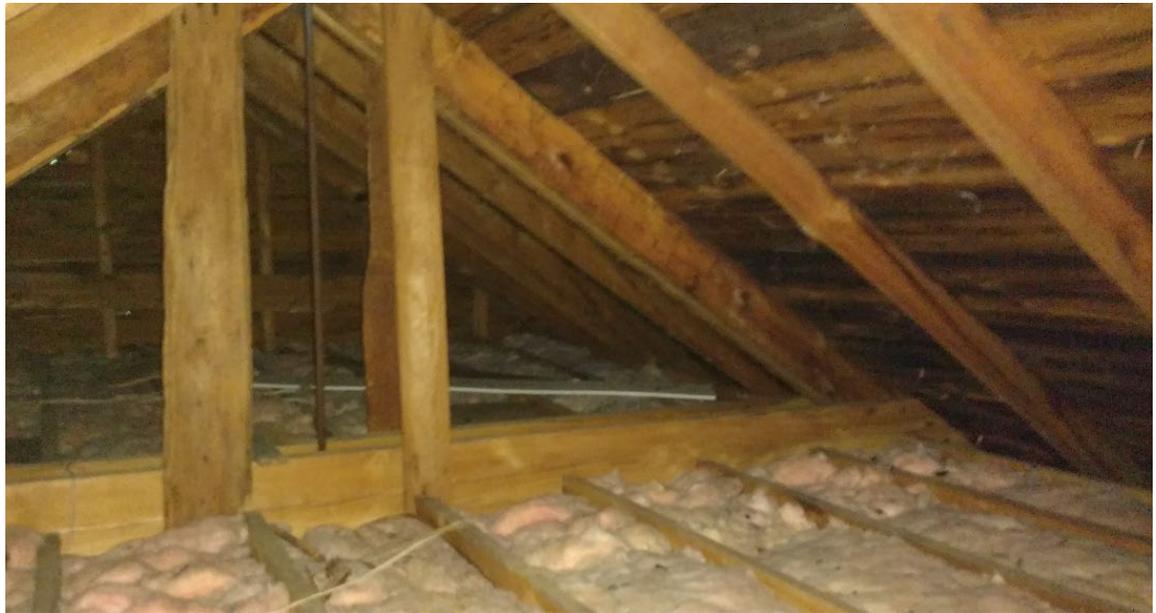
Figure 30 - 1885 Grange ceiling framing with 20<sup>th</sup> century ceiling insulation

This has overloaded the original construction and led to failures at multiple roof trusses. Attempts seem to have been made at different times to reverse or slow the failure by the introduction of secondary elements. These 'repairs' are not structurally informed and have actually contributed to the severe deflection and deformation of the roof line (see Figure 26 and Figure 33).

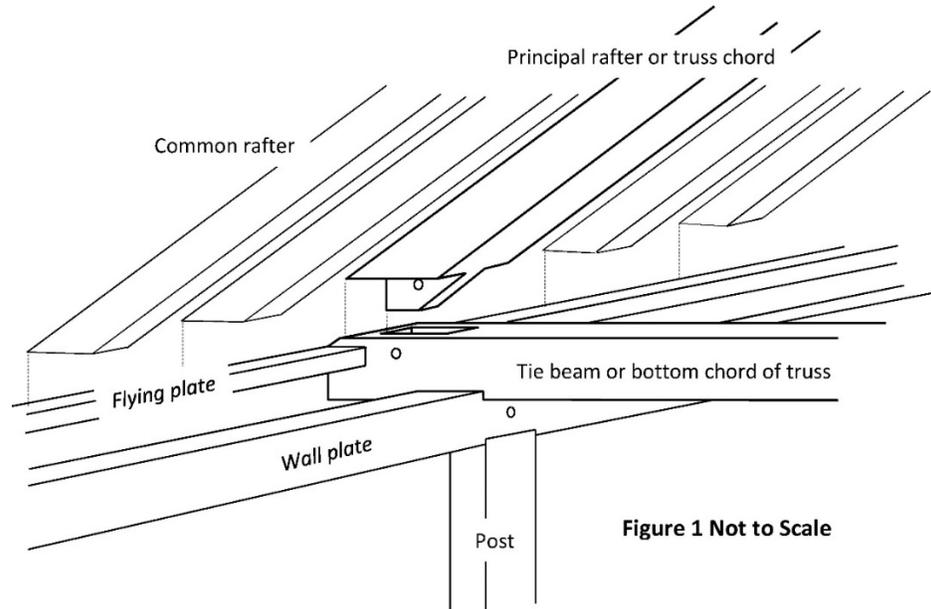
Figure 35 – diagram of rafter connections to wall plate

Distortion at the eaves and visual evidence in the attic (see Figure 36 and Figure 37) suggests that the failing trusses have not pushed the north and south walls apart. No evidence of significant wall movement from plumb was detected by field measurements. The outward movement of both rafters and upper truss chords has pushed the soffit and roof fascia trim into a bow.

*In summary, the reason for the deflections of the roof is a failure in the joints at the feet of the principal rafters of the building, which are the top chords of a series of kingpost trusses. This failure led to the subsequent outward slippage of the feet of these rafters or upper truss chords. Movement of the upper truss chords (principal rafters) has caused subsidence of the purlins that span the intervals between these principal rafters or chords. Downward movement of the purlins, in turn, caused outward slippage of the feet of common rafters, which have followed the feet of the principal rafters or truss chords in moving outward. The results have been the dropping of the ridge of the roof toward the eastern end of the building and the outward bulging of the eaves cornices of the structure as the rafter feet have spread.*

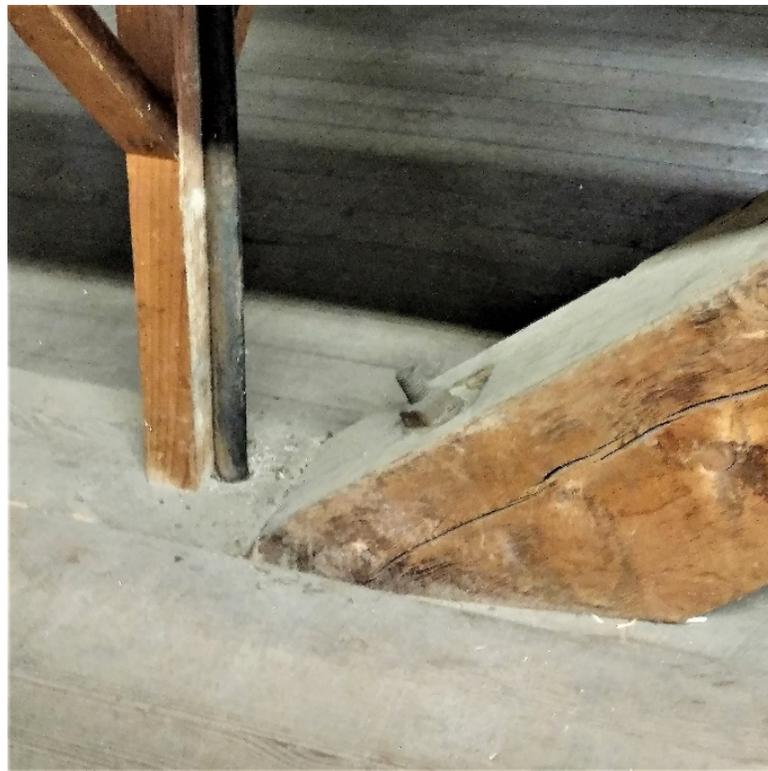
Mr. Garvin is of the opinion that the failure occurred prior to the 1885 Grange modifications and that thru-bolts at the heel of the trusses were attempts to correct and restrain further slippage. Alternatively, the bolts could be original to the 1848 construction of the Howe king-post truss, as are the vertical iron rods which are the principal vertical tension members. Figure 40 – 19<sup>th</sup> century Howe Truss detail showing strut 'heel' mortised into bottom chord and bolted (from Grasmere Grange – Goffstown Town

Figure 39 – 19<sup>th</sup> century Howe Truss detail (Grasmere Grange, Goffstown c.1889)

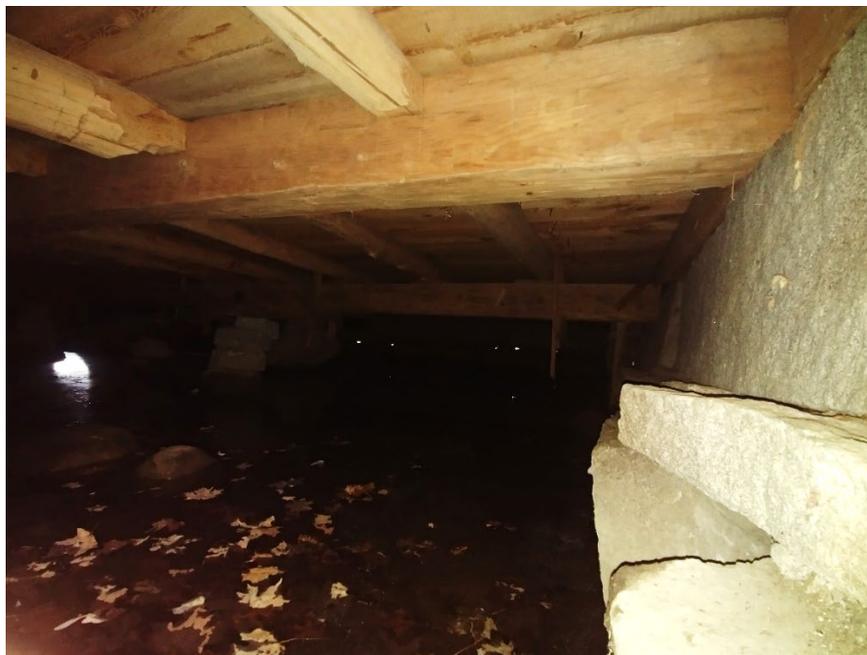
Structural deficiencies at the roof level may have been exacerbated by paving and grading changes in the immediate vicinity of the building, which appear to have directed all water runoff to the crawl space below the building, with no easy outlet. As a result this area is flooded, and allowances should be made to correct problems such as collapsing stone rubble foundation elements and rotting timbers ( see Figure 43 - Flooded Crawl Space).

Figure 41 – Crawl space and First Floor Framing

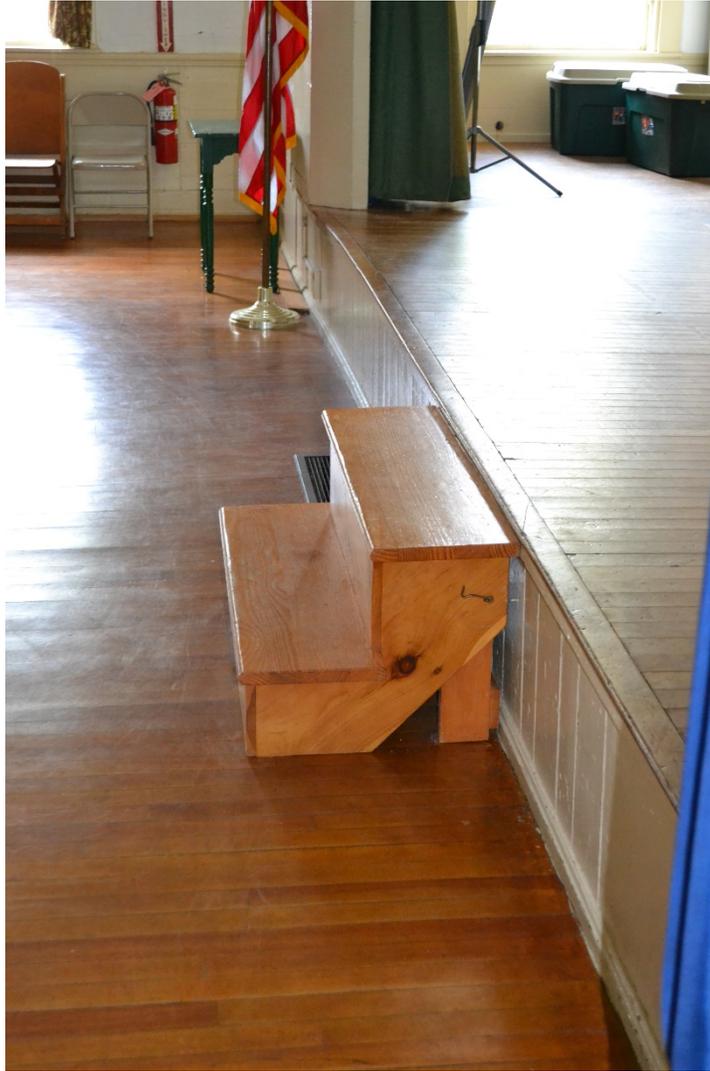
These foundation issues and structural settlement problems can be seen at the main hall level, where the undulating floor structure is prominently seen along the face of the platform stage.

Foundation settlement and/or pier collapse in the north-east corner has resulted in a floor level drop of 2 ½ inches over a horizontal span of only 8 feet at the left side of the stage.

Figure 45 – Flooring change from hall to stage

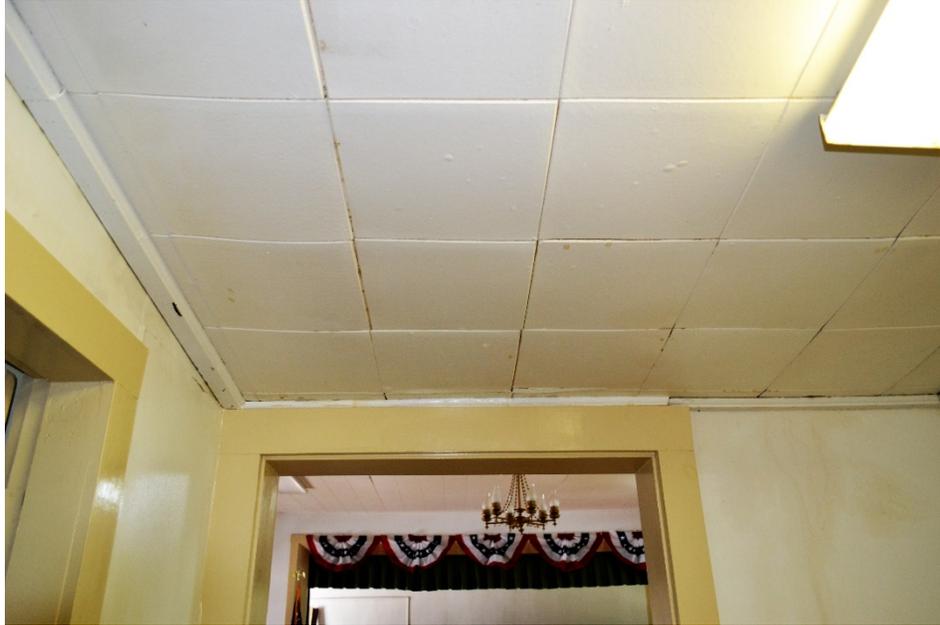
Generally, on the first floor, interior woodwork and finishes are in good restorable condition, given the age of the building. Little evidence of multiple applications of paint or other applied finishes exist, and original materials are clearly evident. The original ceiling is obscured by a application of acoustical tile – most likely installed on wooden furring directly below the original plaster and lath.

Figure 49 – 12x12 ceiling tile applied to sloped framing of original balcony

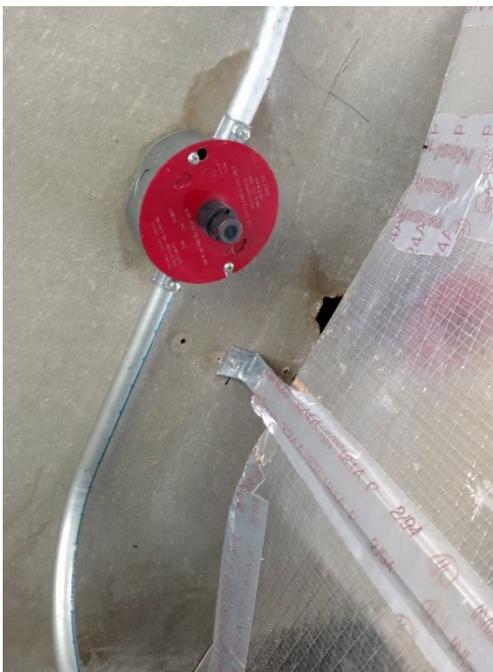
Figure 52 – Fire safety devices in furnace room

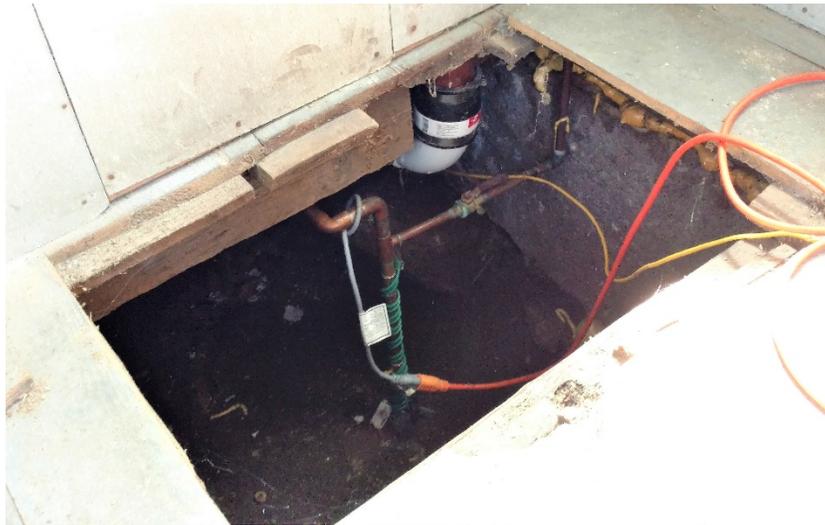
Figure 53 – Water supply in crawl space

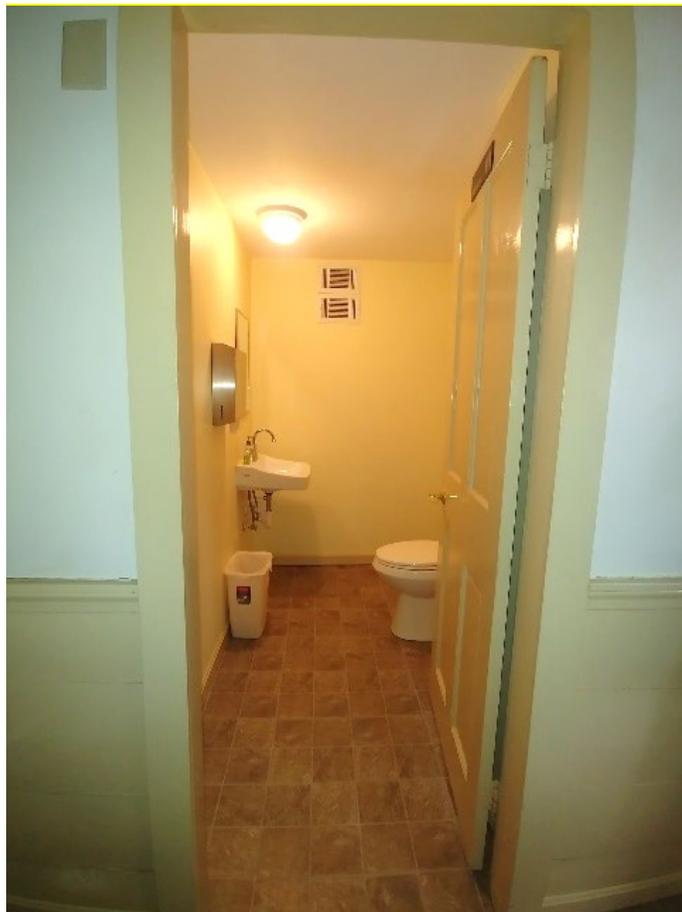
Plumbing fixtures in the serving kitchen and public restrooms are in excellent condition, having been newly installed during prior phase efforts to restore the Hall.

Figure 54 – One of Two Toilet Rooms

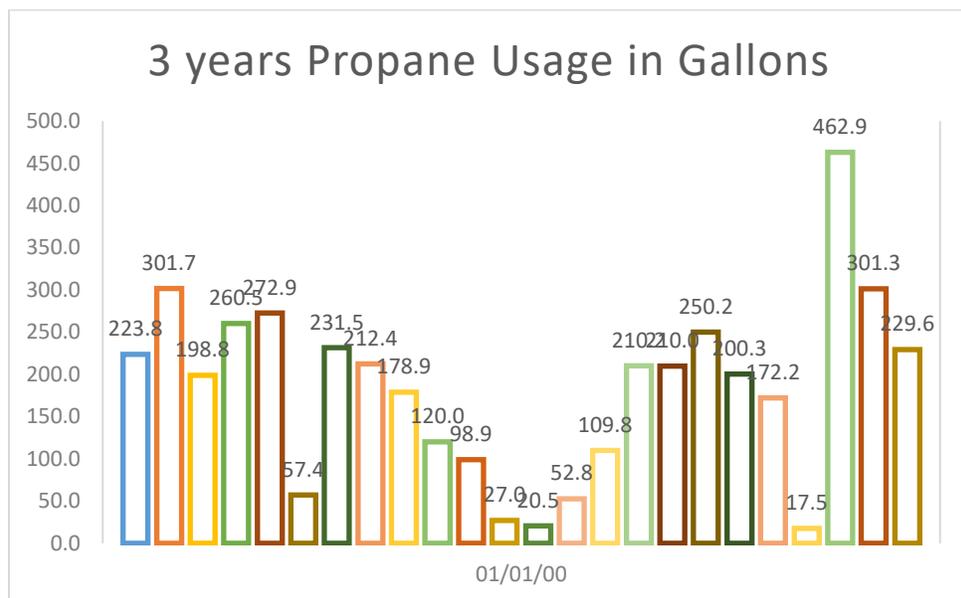
Figure 55 - Propane Usage for Heating

Propane use for heating between January 2015 and March 2018 totaled 4,420 gallons – a rough average of 1,400 gallons per year (equivalent to 406 million BTU) Mason averages about 6,900 degree-days per heating season, so the energy use intensity of the existing 2,150 square foot building is 27 Btu/sf/DD. This is quite high, and we would anticipate a reduction in usage after removing the upper dining room infill and re-insulating the restored attic.

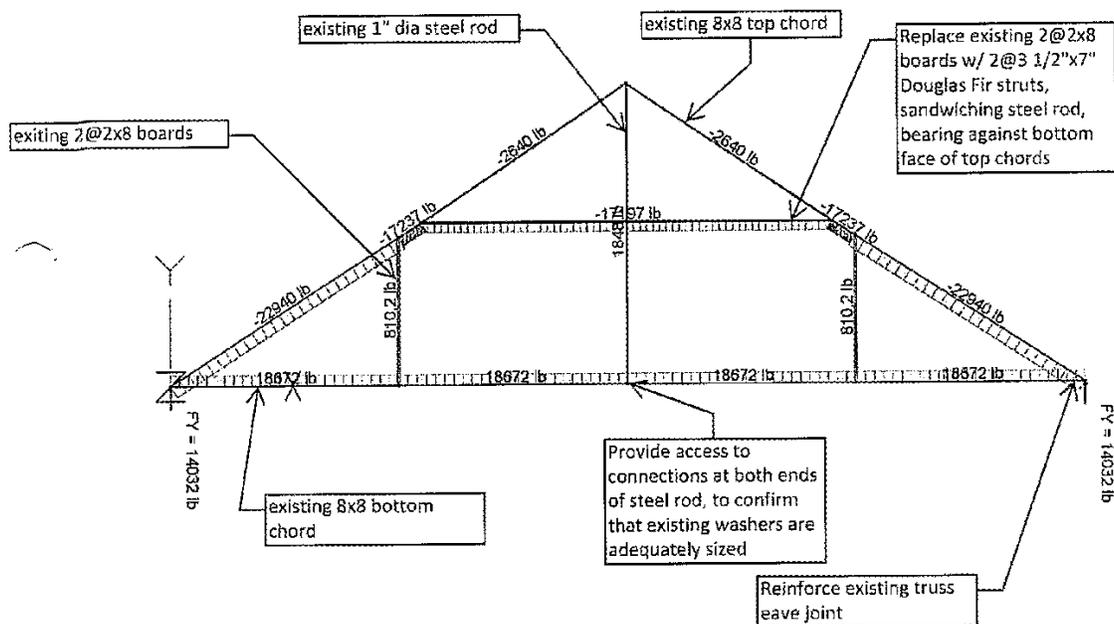
A meeting arranged by the Andrew Cushing of the Historic Preservation Trust allowed for further input from a structural engineer well versed in heavy-timber joinery (Annette Dey, PE). Ms. Dey provided some independent calculations (see Figure 60 - Structural Analysis) confirming the heavy loadings efforts to retain the Grange level infill placed on the structure, with over 18,000 pounds of horizontal thrust to be carried at the truss heels at the eave joints.

Figure 58 - Structural Analysis by Annette Dey PE

Repairs contemplated by Ms. Dey would salvage the structural function of original truss members by modifying each truss with additional framing above the upper ceiling line and by opening up the roof to rebuild and reinforce each heel joint.

The consensus of those involved (Annette Dey PE, Andrew Cushing, Mason Town representatives and Architect Charles Michal) was that removal of the 1885 construction was necessary and would allow the opportunity to either re-build the trusses or otherwise provide a structurally sound roof. As much dead-load (of building materials) as possible should be removed.

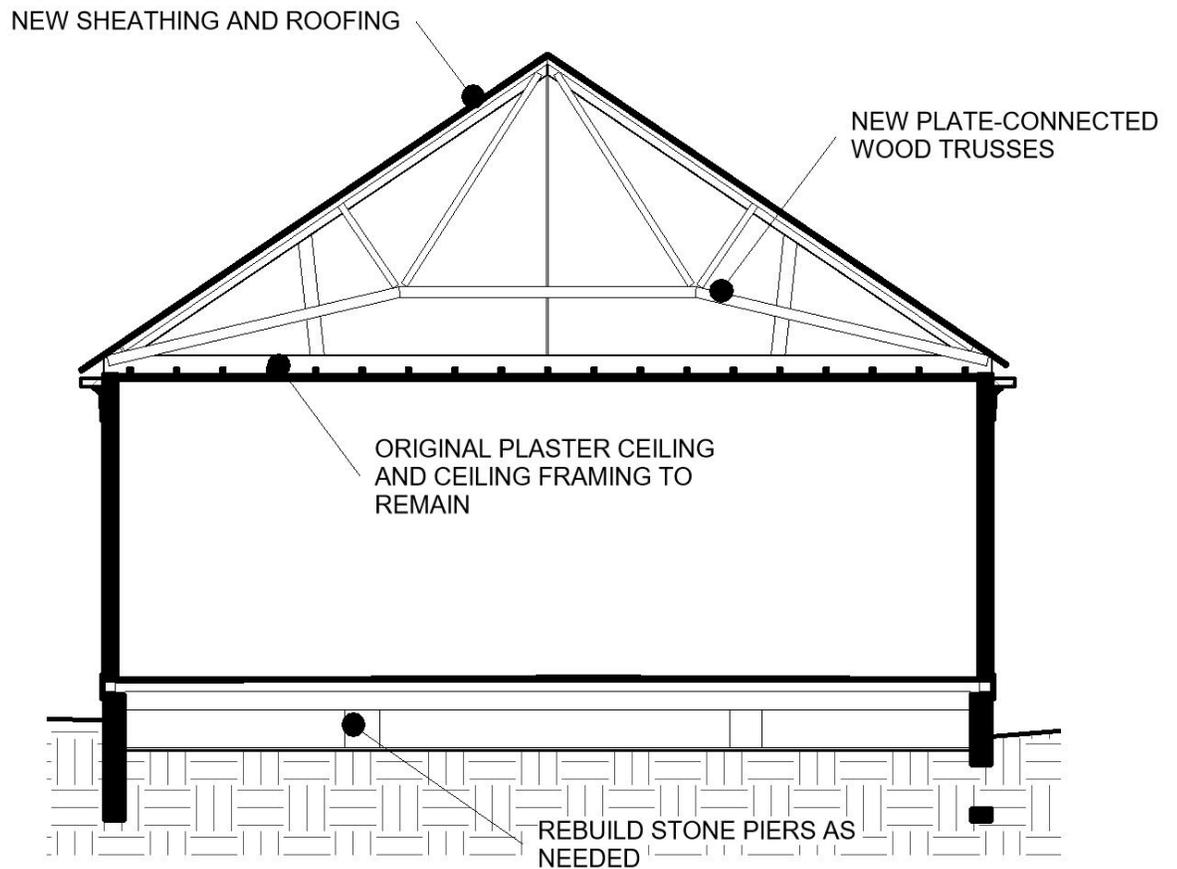
Figure 59 - Reconstructed Roof Section

Once that is accomplished we recommend removing all sheathing, both plywood overlays and original board sheathing, from the original rafters and trusses. This must be done in the eastern four of the five truss bays. (This can be done sequentially if necessary to reduce the exposure of the building to the weather. Within reason, each bay can be treated separately.)

Once the sheathing in a bay section is removed, the horizontal roof purlins and secondary rafters would be removed. Conventional wood metal-plate connected trusses on nominal dimensional lumber can then be inserted to span from exterior wall to exterior wall, and sit above the original ceiling framing, leaving it undisturbed.

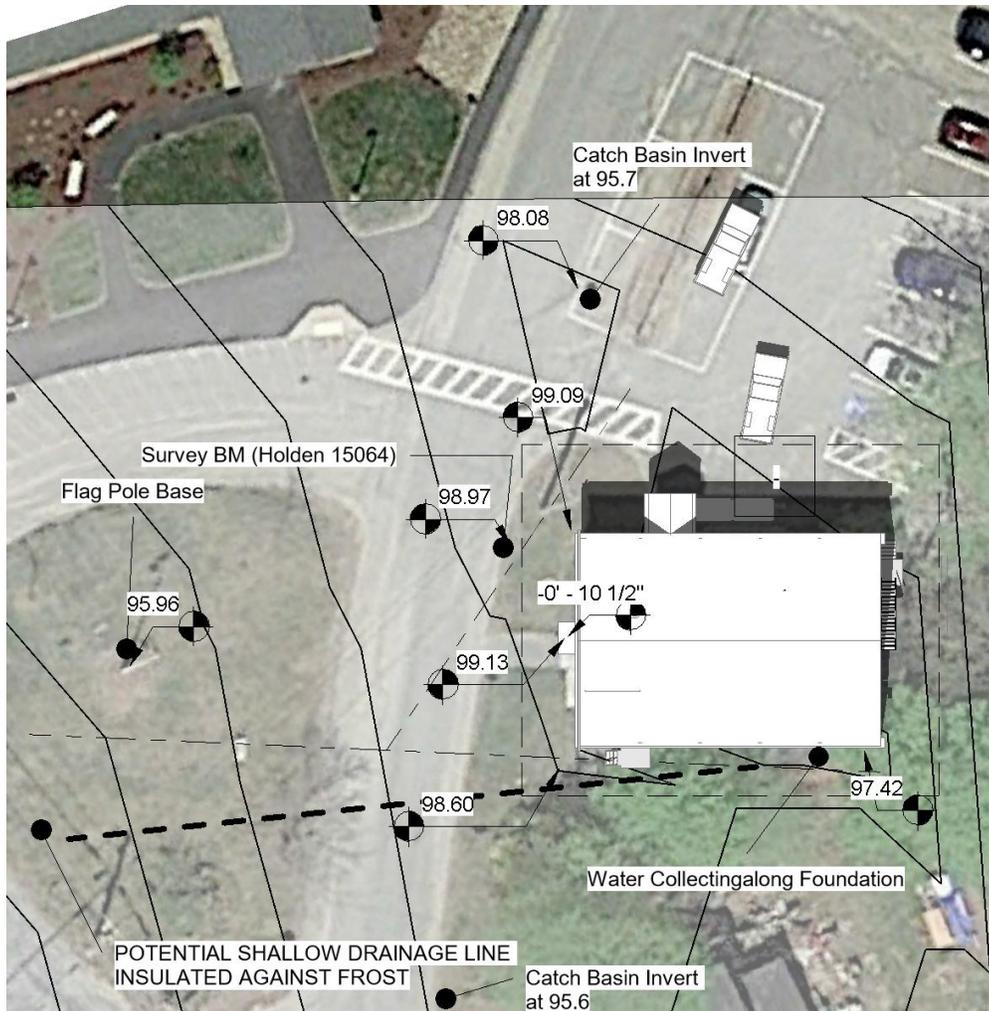
Figure 60 - Site Spot Grades

Poor drainage around the building needs to be addressed. Our recommendation is that the perimeter around the north, east and south sides of existing rubble stone foundation be excavated to allow a French drain system to be installed, to be connected to new storm drainage extended west from the site across and below adjacent roadways, to drain to daylight on the commons. Figure 62 - Site Spot Grades – illustrates how approximately 130 feet of storm drain installed under the street may be possible.

Drainage on the north side can run some distance parallel to the foundation, so not to force reconstruction of the ADA entry ramp. Cutting and patching of asphalt at the drive and parking should be anticipated. The extremely low, locally depressed ground to the south side should be drained with some permanent drainage structures to daylight or other functioning storm drainage in the vicinity.

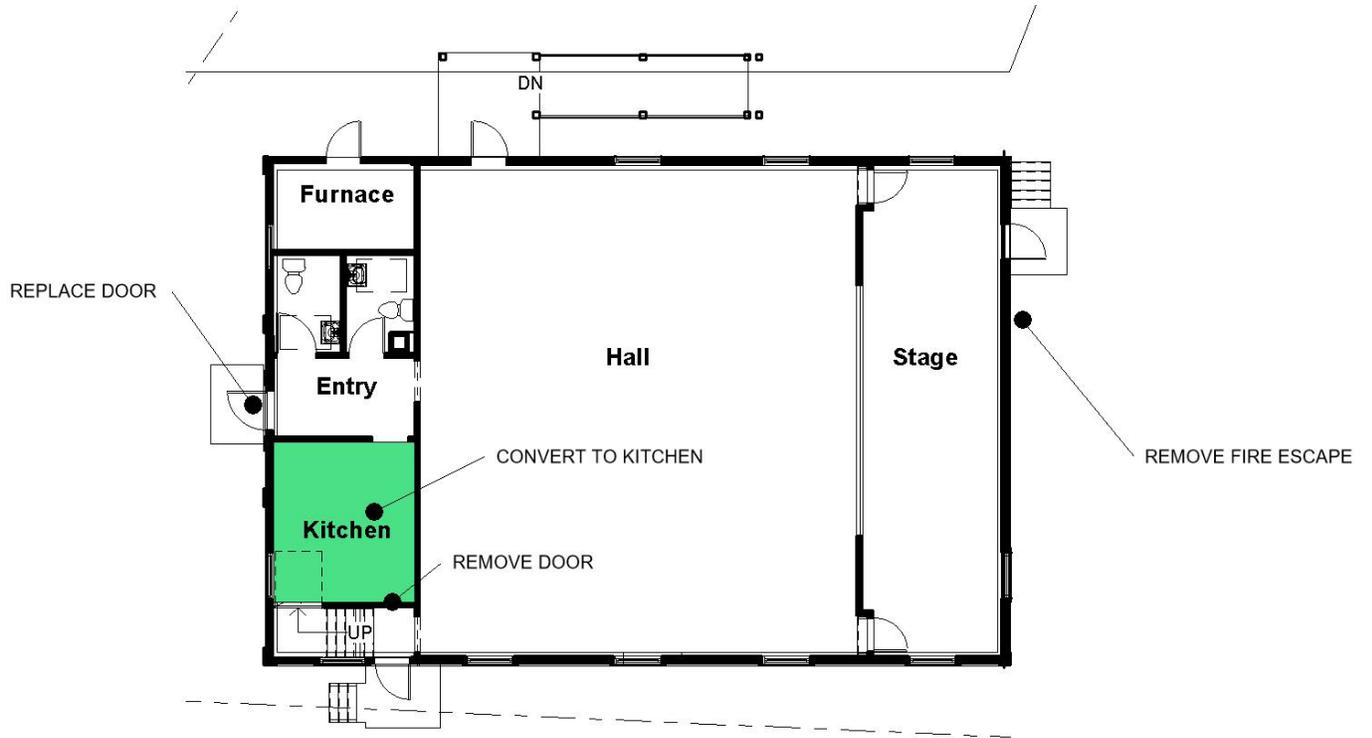
Figure 61 – Proposed First Floor Plan

Primary first floor renovations involve restoring the plaster ceiling above hall and stage and re-configuring the current small office to accommodate a small warming kitchen to support public use of the main room. This is shown in Figure 63 – Proposed First . . . Removal of one door will improve the usability of the space. General interior repainting and floor refinishing can be budgeted as well.

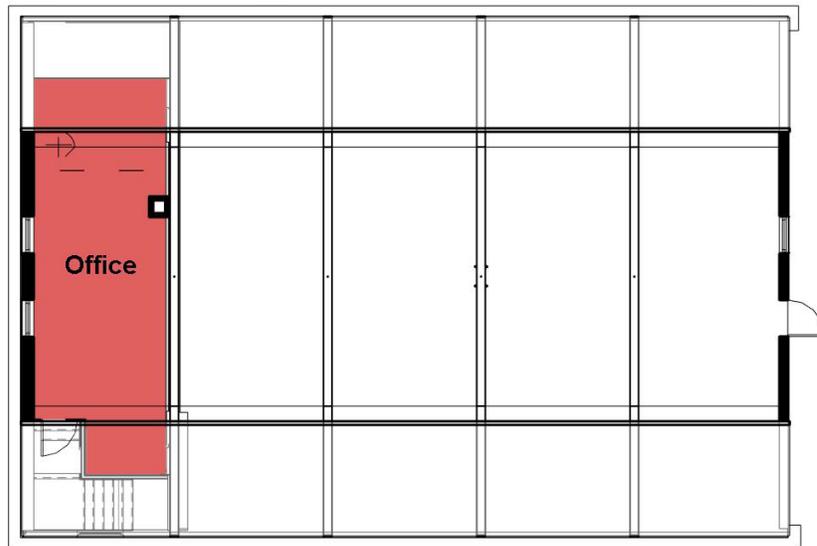
Figure 62 – Proposed Upper Level Plan

The original gallery, which does not hang from the roof above but is supported by first floor walls, would be retained. Recommended plan changes at this level are to use the former Grange kitchen area as an office/small meeting room. Repair and restoration of existing painted finishes is to be expected, as well as new partitions to isolate this partial floor from the re-created attic.
